SUBJECT: SWINGING BRIDGE REPORT

Re: Bridge Inspection: Coast Fork Willamette River Pedestrian Bridge
OBEC Project No. 158-14

Subject: BRIDGE CLOSURE RECOMMENDATION

Coast Fork Willamette River Pedestrian Bridge Inspection and Load Rating Summary

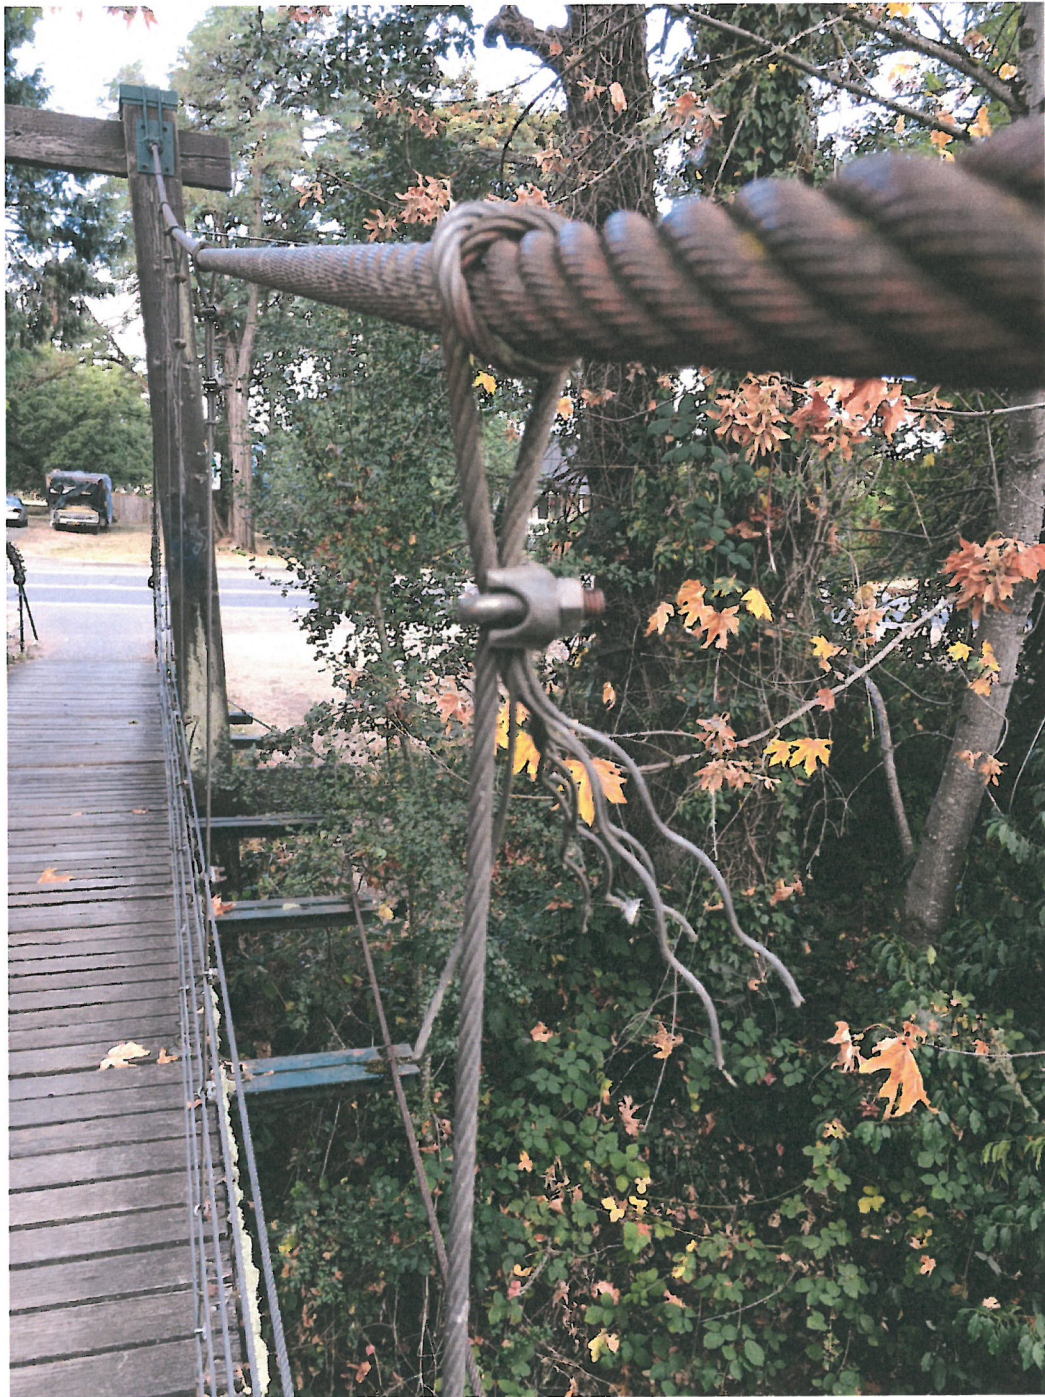
Photo 3 – Splayed Suspension Cable

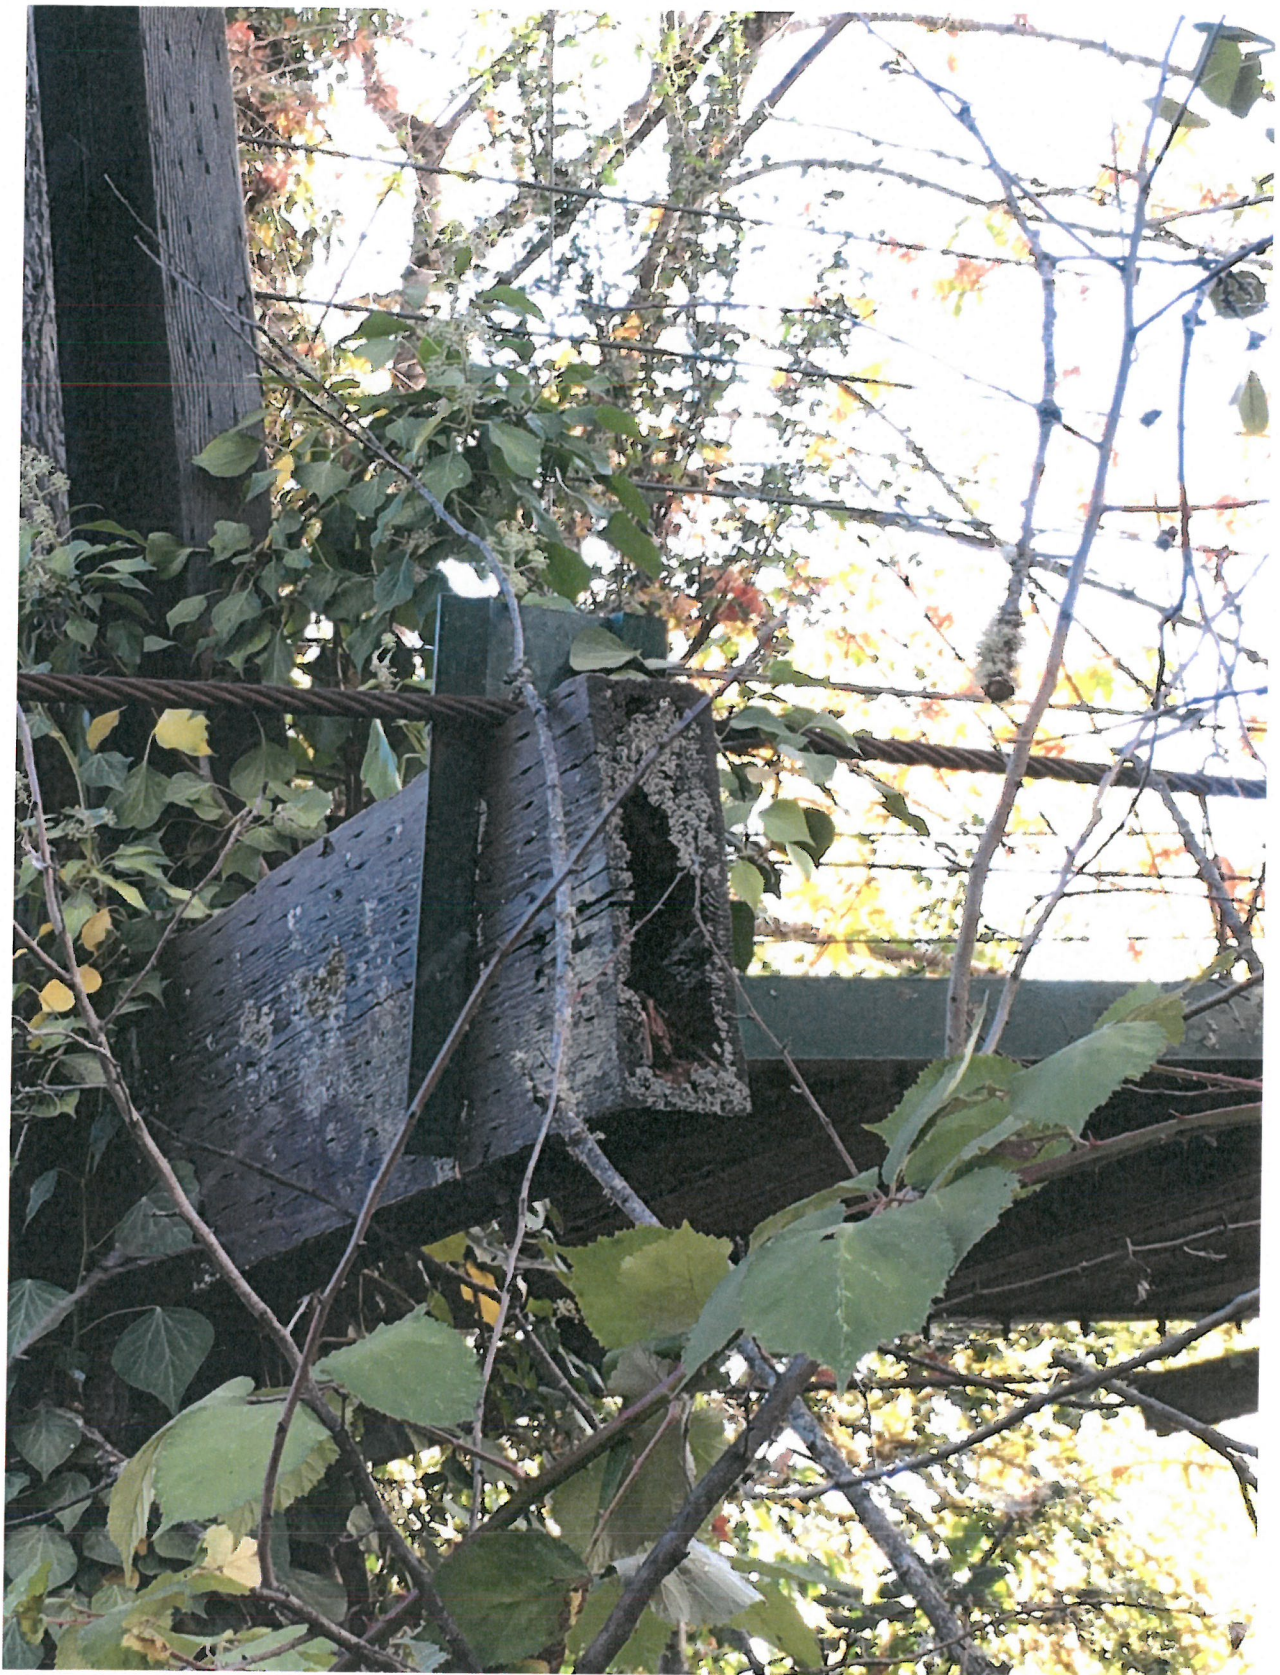
Photo 4 – Decayed Floorbeam Bent 2

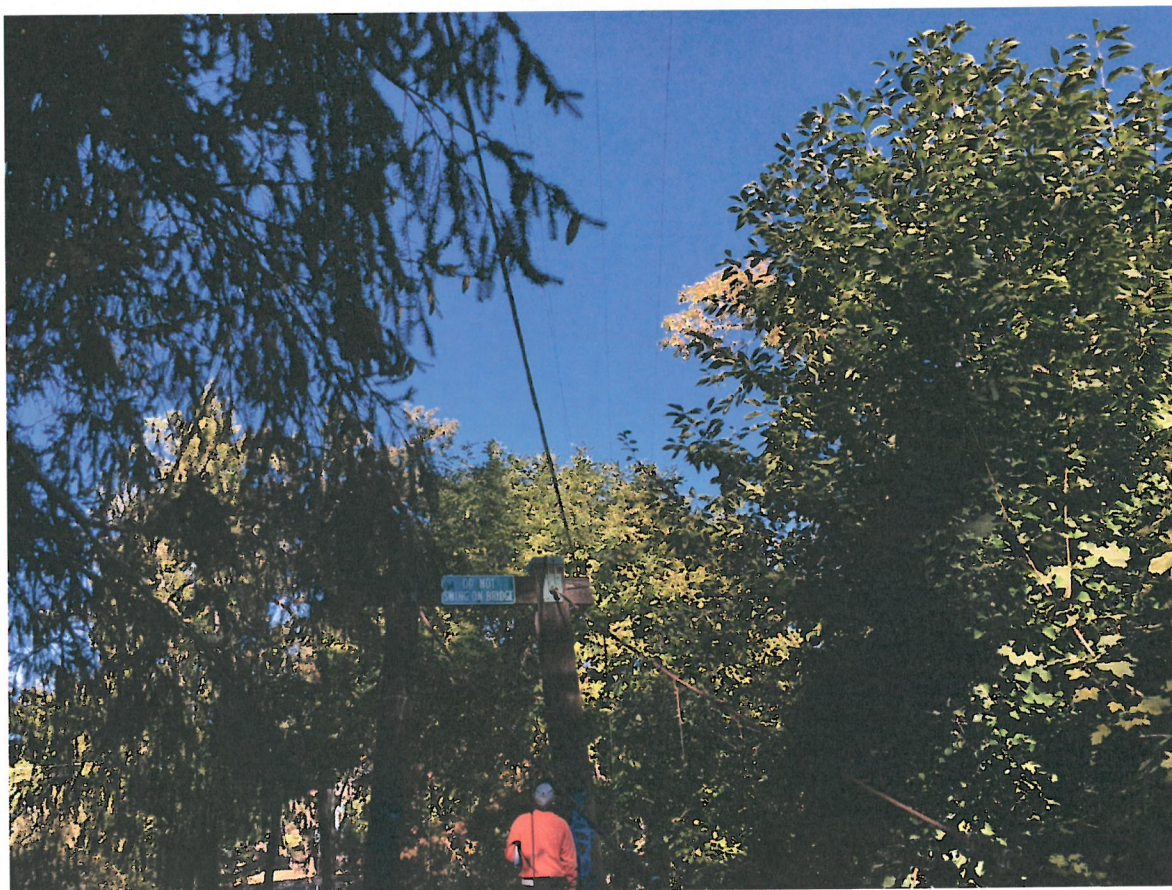
Photo 6 – Overhead Powerlines Span 3

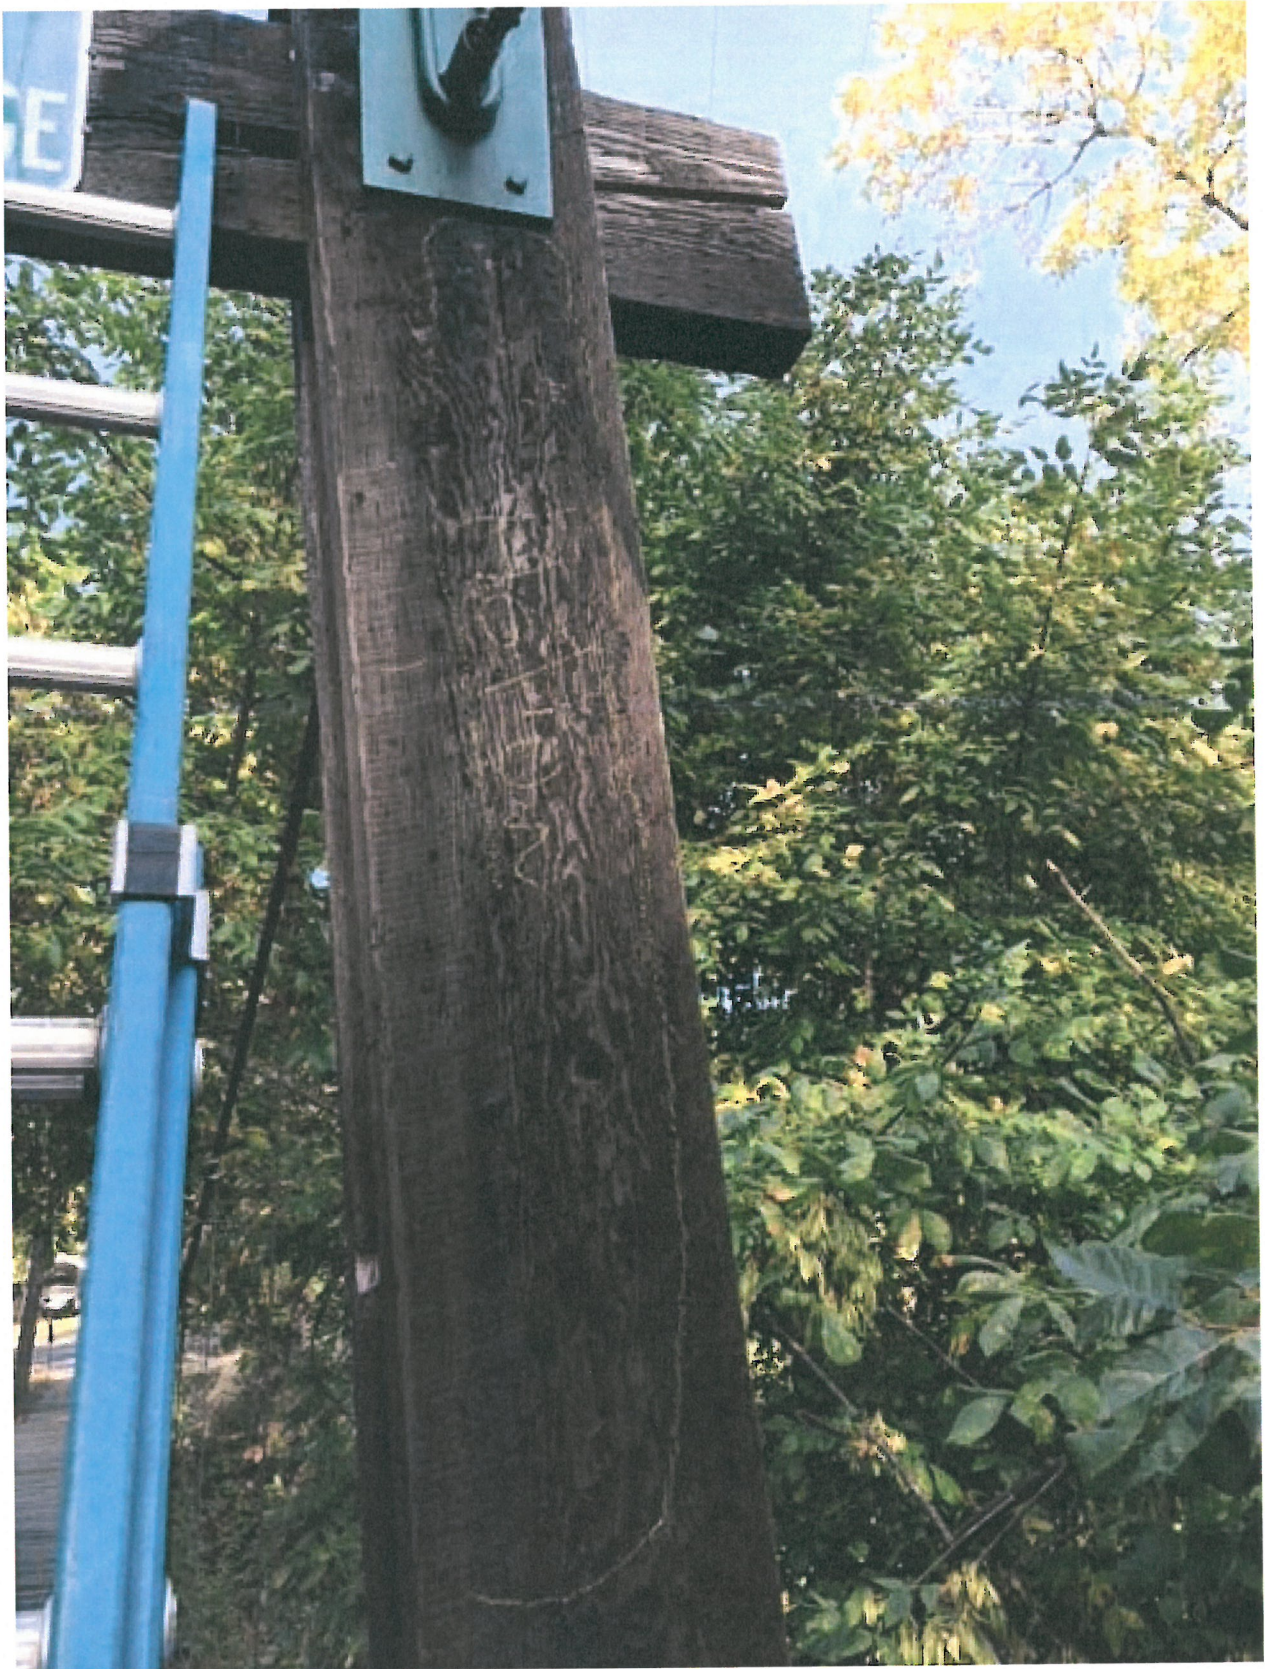
OBEC's last inspection of this structure was in 2002, and repairs were recommended to be completed on the towers as soon as possible. It is our understanding that those repairs were never completed. Our most recent routine inspection took place at two different times. Jared Trowbridge and I were on-site on August 29, 2016. A second inspection was needed to view areas thought to be accessible with small ladders. Mike Hawkins and Andy Fortner of OBEC completed a follow-up inspection on September 9, 2016. We have identified extensive decay in the vertical towers, and some decay of the horizontal braces at each tower. The amount of decay in the towers was estimated in 2002 to be 50 percent of the vertical member's capacity. These members now have approximately 1 inch of outer wood remaining.

This area of decay in the vertical towers is the area that supports the main suspension cables. The extensive decay is compromising the support for these cables which poses a serious risk that could result in a catastrophic failure. After discussing the results of our inspection, we have concluded that the bridge's capacity is in serious jeopardy. Due to the extensive decay in the main structural members, the bridge cannot safely support pedestrian traffic, and there is potential risk of catastrophic failure without warning. These are the reasons for our recommendation above.

Photo 8 – Decayed Column

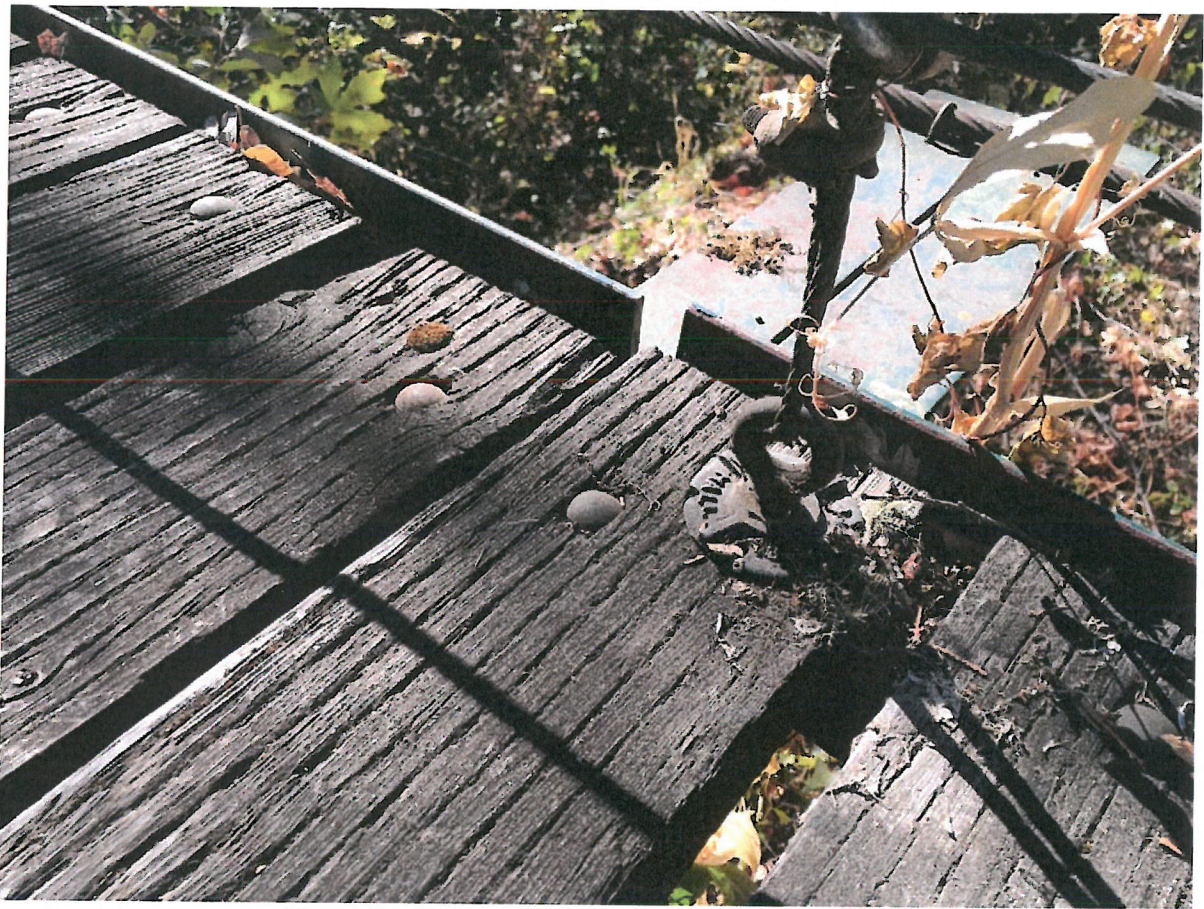
Photo 9 – Typical Suspender to Deck Connection

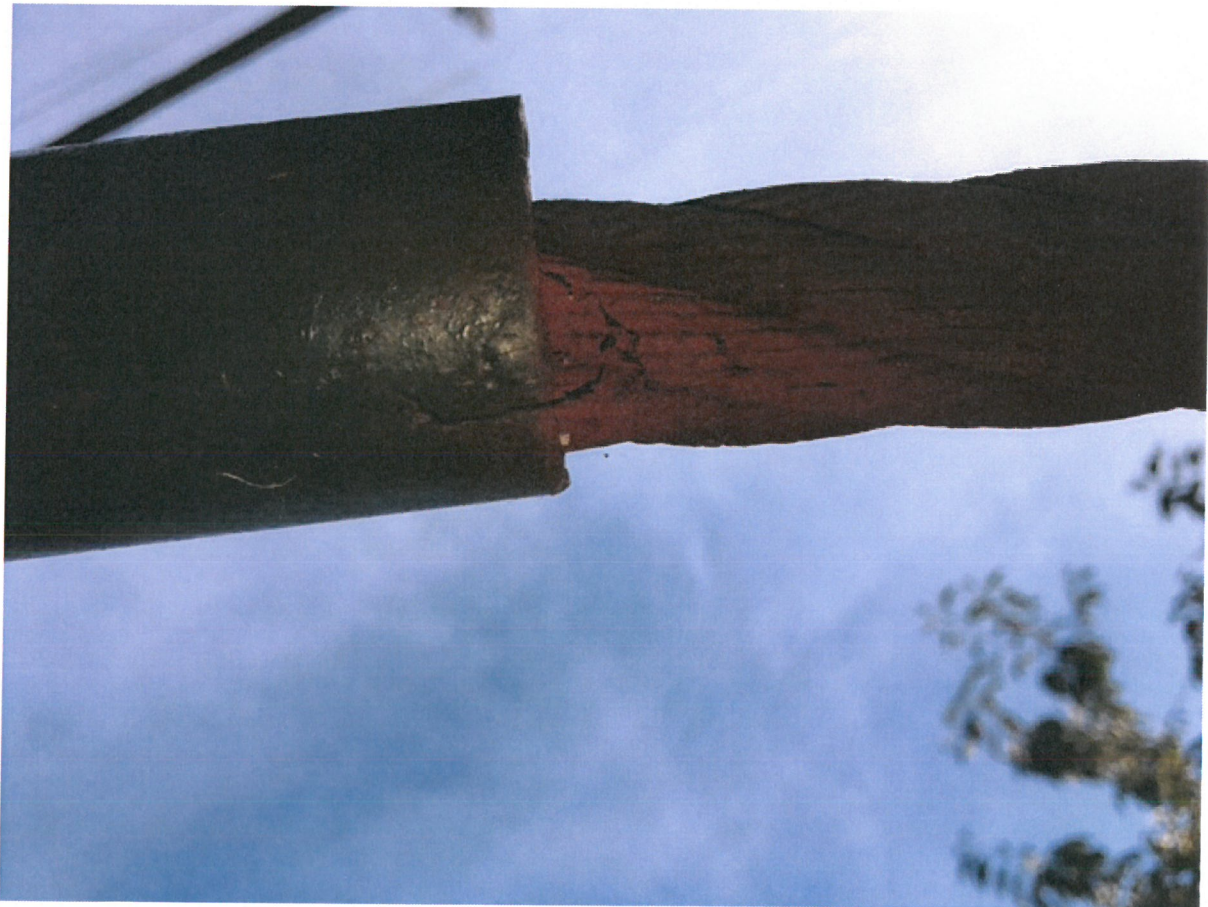
Photo 10 – Corroded Suspender Cable
