Masonry Conservation Handbook

Cottage Grove, Oregon

University of Oregon
Architecture and Allied Arts
Historic Preservation Program

Authors:
Graduate & Undergraduate students
AAAP 4/510: Building Pathology - Masonry

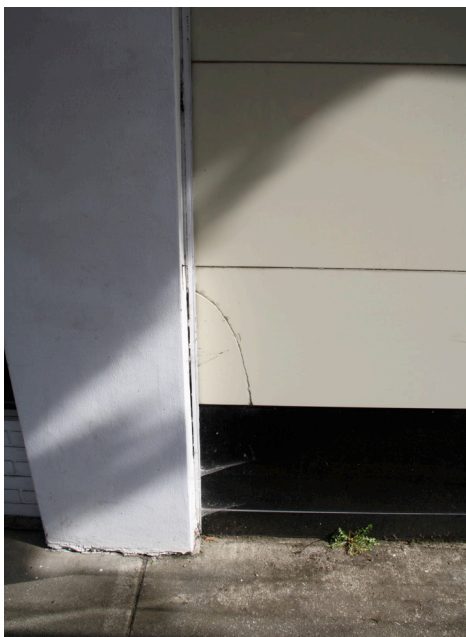
Structural glass panels were adhered directly to a dry, smooth, masonry substrate with the generous use of daubs of asphaltic mastic. Metal brackets, anchored into the backing masonry every other course, provided an additional source of support. A 1/16" cork cushion separated horizontal joints, and vertical movement gaps of

1/32" between adjacent panels were buttered with color-matched joint cement. Many colors were available, especially during its peak popularity in the mid-1930s.

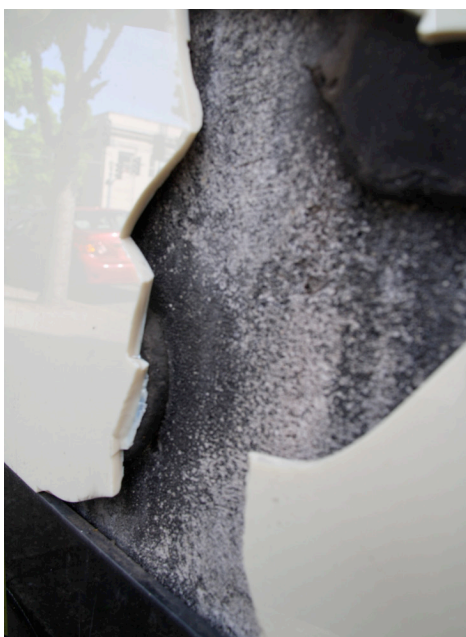
Over time, the original joint cement will deteriorate. While itself a seemingly small difficulty, it can lead to much bigger issues over time. Subsequent exposure to water can deteriorate the anchoring system, as well as the masonry structure beneath. This is especially problematic if any water that enters becomes trapped behind the material.

It is important to repoint cement joints in a timely manner as they become cracked or exposed. However, it is not recommended to use the original joint compound materials as these have a limited lifespan and quickly become stiff and brittle. Silicone compounds provide a recommended alternative, when tinted to match the color of the glass. This technique is also recommended for patching chips or minor cracks in the panels themselves.

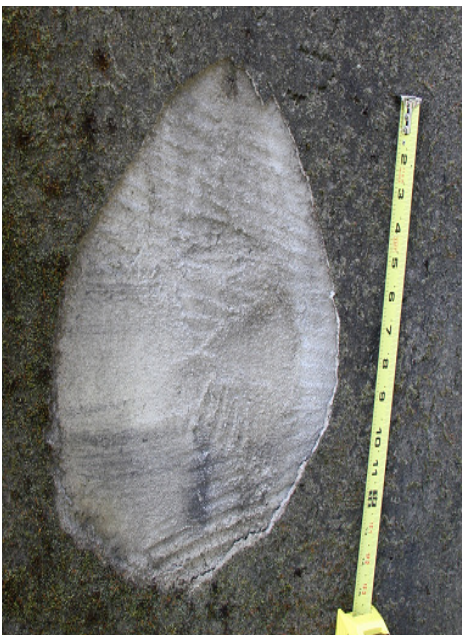
In the interest of saving and preserving as much as possible of the historic stucco, patching rather than wholesale replacement is preferable. When repairing lime-based stucco applied directly to masonry, the new stucco should be applied in the same manner (directly onto the stone or brick). It is vital that this new stucco be compatible with its historic counterpart, which should be carefully analyzed to inform the selection of a mix for repair. When patching or repairing a tinted historic stucco, it may be possible to determine through visual or microscopic analysis whether the source of the coloring is sand, cement or pigment. Many stucco buildings have been painted over the years and will require repainting after the stucco repairs have been made.

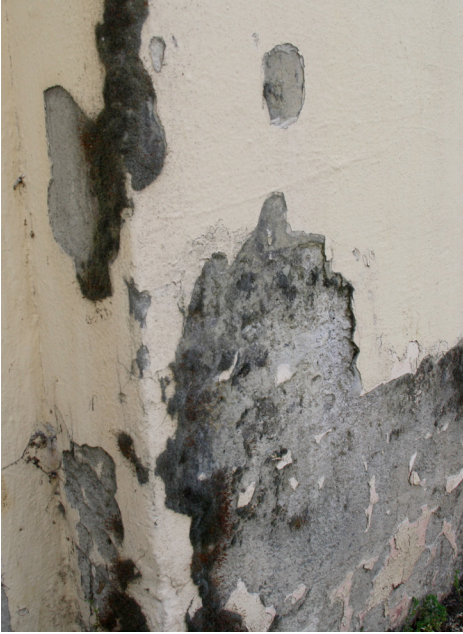
intercoat is peeling. Crazed paint is frequently recognizable by its thick and brittle surface.

- **Wrinkling** occurs when the topcoat dries too quickly. If this occurs while the lower coat remains wet, it will continue to move and cause a wrinkled pattern easily seen at the surface.
- **Sagging**, or running, may occur when too much paint is applied in a single coat; when a paint is excessively thinned and then applied; when paint is applied under improper conditions, such as high humidity; when the surface is not cleaned properly prior to painting; or when the surface is too glossy. Sagging paint appears to be dripping or drooping, even when dry. If the paint is still wet when this occurs, simply redistribute the paint to achieve a more even consistency.

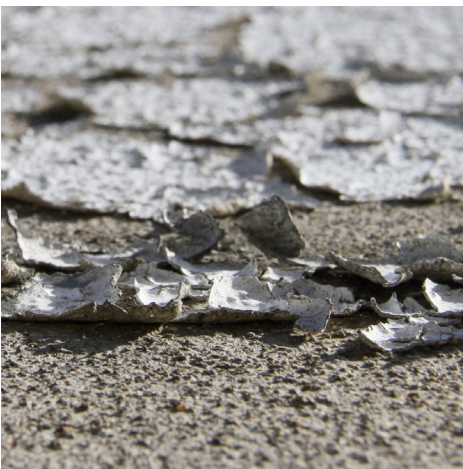
- **Alligatoring** occurs when a second, incompatible paint coat is applied to a previously painted surface, or when a second paint coat is applied too soon. A deep relief-cracking pattern, which resembles the texture of an alligator's skin, is the common symptom of this condition.
- **Peeling** occurs moisture becomes trapped beneath the surface of the paint; when the surface was improperly prepared for painting; when the paint has poor adhesion to the substrate; when the quality of the paint applied was low, or when blistering paint was allowed to progress. (Blistering paint is a class two problem that is less common in masonry buildings).

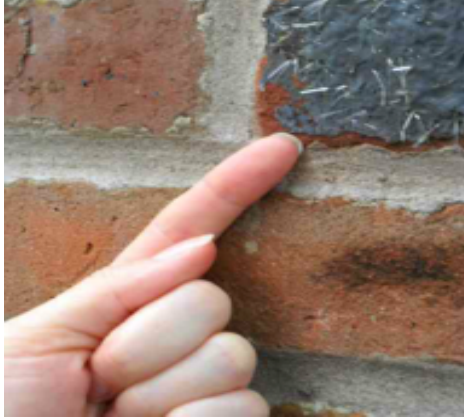
A) Clean: no lime. This exterior chimney was built in 1982 and uses a cement binder.

age to guess a mortar type, a series of simple tests are the best way to identify mortar ingredients, beginning with the “Finger Test” for lime—pictured to the right.

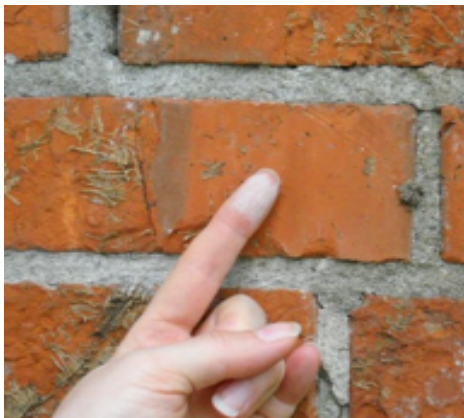
B) Chalky: significant lime present. This exterior chimney was built in 1928 in Eugene and likely uses a manufactured lime binder.

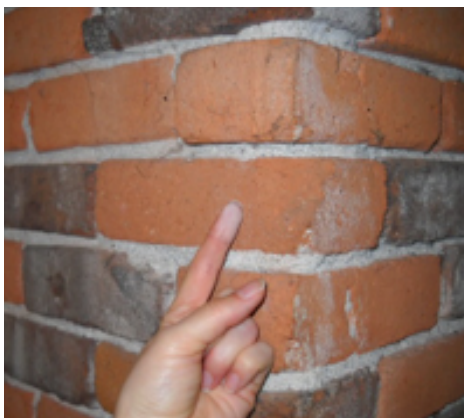
C) Very Chalky and Soft: natural lime. This interior chimney was built before 1900 near Cottage Grove. Its mortar easily crumbles to the touch.

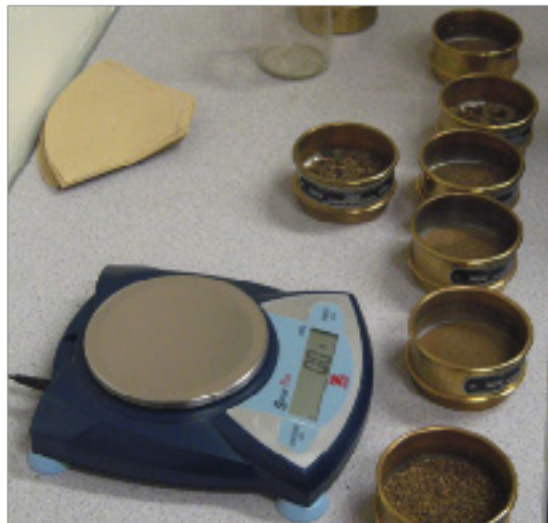
The binder test dissolves lime, leaving behind aggregate. If then sent through a series of sieves, the aggregate itself can be separated by size. This allows for matching of the original aggregate's proportions, strength, texture, and color—helping the new mortar to blend in. The mortar aggregate pictured below was taken from a Cottage Grove building, and matches sand gathered in the Coastal Fork of the Willamette River.

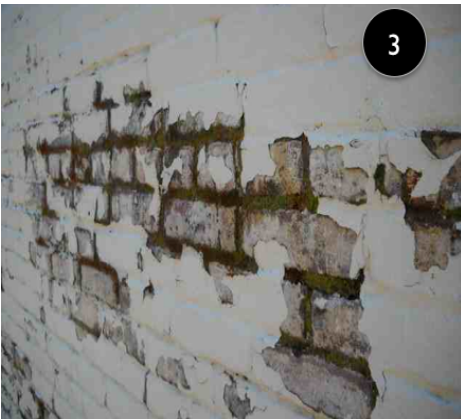
Figure 3:

Damp mortar covered with moss. The mortar is performing well under difficult circumstances. The root problem with the wall is “rising damp” and is not a mortar-specific problem.

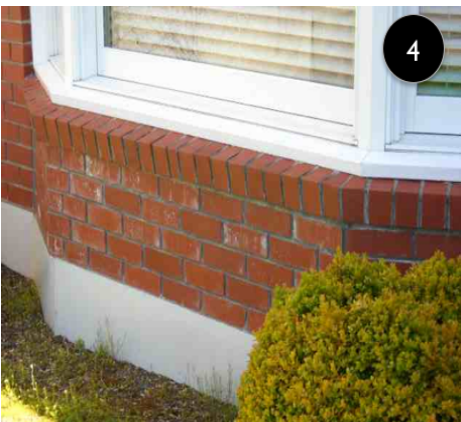
Figure 4:

Salt crystallization on a modern brick and cement wall. Repointing with a lime mortar might help fix the problem.

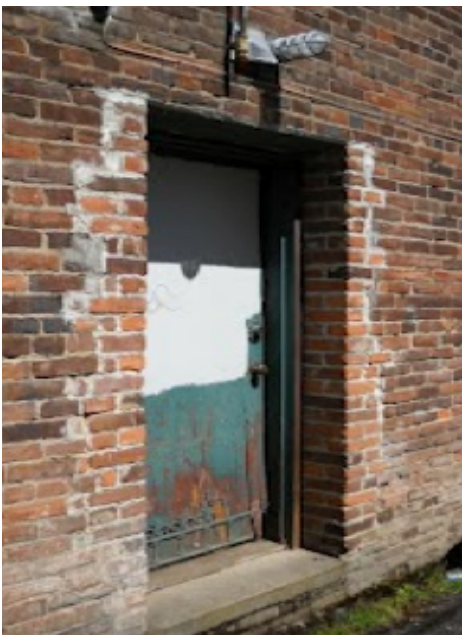
The white cement repair pictured above does not match the color, texture, or workmanship of the original mortar. Unfortunately, it will be nearly impossible to remove the dense cement mortar without irreparable damage to the bricks.

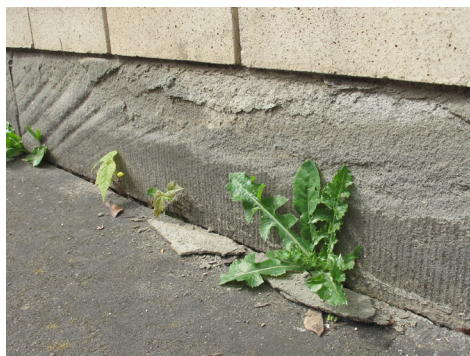
Figure 11: Coving from rainwater, resulting in delamination of the sandstone foundation. Plant growth also indicates moisture.

Coving is the process in which splash back from rainwater hits the foundation several inches above the ground. Repeated action usually creates a horizontal inden-

tation where the water hits and erodes the stone; spalling or delamination usually follows the erosion. The additional water at this line can also affect the entire area, especially if there are pre-existing gaps in the mortar, or the stone has been otherwise compromised. This becomes problematic during freeze-thaw cycles as it places extra pressure on the microscopic pores of the stone. If left untreated, the deteriorating foundation can cause additional stress on the surrounding load-bearing masonry, sometimes leading to structural failure. Improper water shedding is a common cause of masonry distress; fortunately, it can usually be repaired. In the case of many buildings, a quick visual inspection can easily identify problem areas that require maintenance

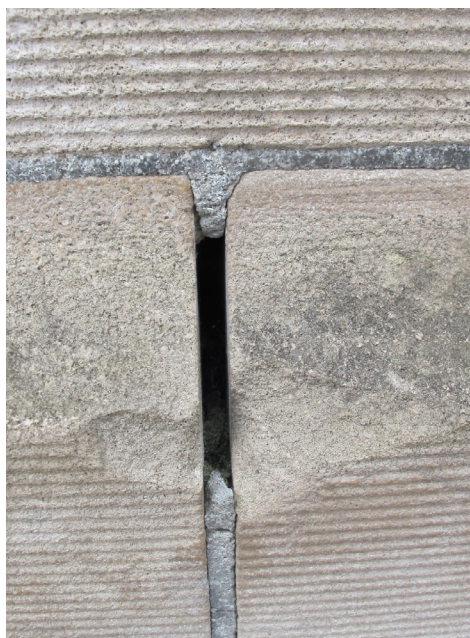
Figure 12: A compromised mortar joint has left the stone exposed to weather, resulting in spalling of the masonry.

When problems with stone masonry are left untreated, they can precipitate more extensive damage, ultimately affecting larger sections of a building and its usability. This is often the case with broken mortar joints (Figure 12), which readily admit water into the wall cavity, quickly causing other issues as serious as settlement and corroded wall ties. Soft stone, such as sandstone, is susceptible to these issues, as shown in Figure 12 where original tooling details have been lost due to the uncontrolled moisture penetration and subsequent failure of the dressed stone, and Figure 13 where a lintel has cracked due to settlement. Once the face of the stone has been compromised, it becomes even more vulnerable to environmental, mechanical and physical stressors.

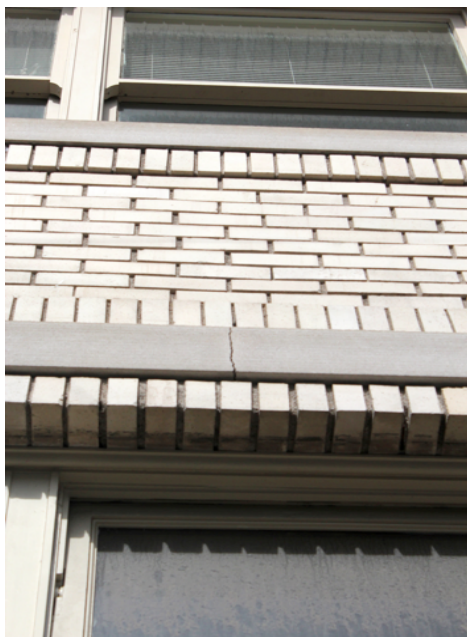
Figure 13: A vertically cracked lintel indicates horizontal settling of the building..

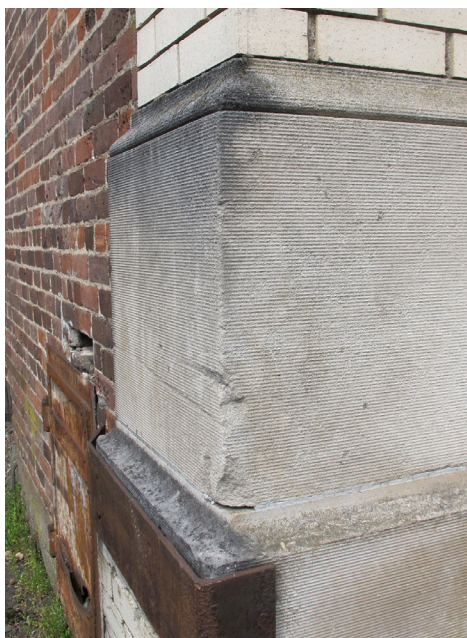
Figure 14: This stone plinth clearly shows soot accumulation as well as damage caused by passing vehicles.

Figure 14 also displays some classic problems found in stone. Damage in the form of chipping has occurred from passing vehicles, which has left several scars. These are both an aesthetic and mechanical concern for the building, as they create new

opportunities for infiltration by foreign substances. In this case, an iron bumper has been attached to the foundation, presumably to protect the remaining stone beneath. Although this is a proactive solution, this area should be monitored closely to ensure that the connections between metal—especially metal that shows signs of rust—and stone do not interfere with one another. Metal expands as it corrodes, and thus, can crack the stone where the rusting anchors are attached.

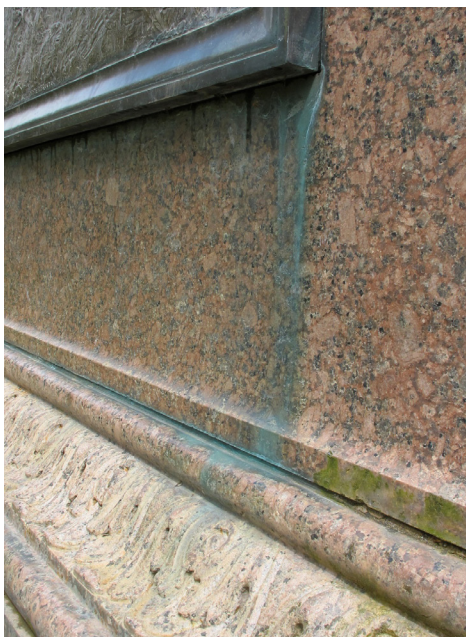
Figure 15: Copper staining, biological growth and missing mortar on the Pioneer Mother Statue require some attention before they become truly problematic for the stone

The Pioneer Mother Statue rests on a massive granite plinth. Although the granite is in relatively good condition, copper staining from the metallic mural attached to the plinth has begun to discolor the granite (Figure 15). This is mainly an aesthetic concern, but it is best for the staining to be removed. Elements that leach out of metal tend to compromise the stone’s integrity because they alter the pH of the surface. The granite base of the Pioneer Mother Statue also displays evidence of biological growth in the form of algae and moss. This is also an aesthetic concern, but the greater meaning behind biological growth is that moisture is often present in the material.

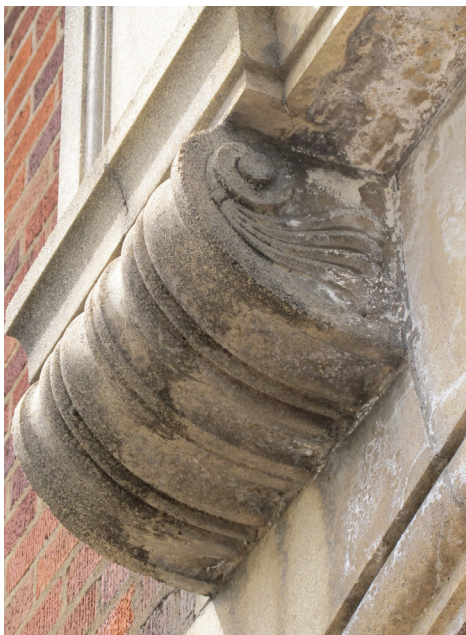
Figure 16: Efflorescence under the stone details of the door surround on the Volcanology building indicates moisture and salt movement through the materials.

Another common problem with masonry results from the presence of excess water. In the case of the Volcanology building, efflorescence, which is the appearance of migratory salts carried by water, has manifested itself on the surface of the stone. Generally, this problem appears as a white or light grey powder (Figure 16). It usually indicates that water has infiltrated the subsurface of the material and has migrated outwards. In many cases, efflorescence can be cleaned using simple techniques and then monitored to see if the problem reappears. It must be remembered

The third major aesthetic concern is efflorescence. When this condition appears, it

may or may not be indicative of a greater problem. For the purpose of this chapter, efflorescence will be labeled as an aesthetic concern, but every building and piece of stone ornamentation will be unique. The problem behind efflorescence is migrating moisture, so this is the first issue to be corrected. The point of water infiltration, whether it is failed flashing or another cause, must be determined and remedied. Only then can the efflorescence be gently washed by hand to remove the powdery white coating. As with all historic materials, the most gentle but effective means such as a soft bristled brush and elbow grease should be used to clean historic materials.

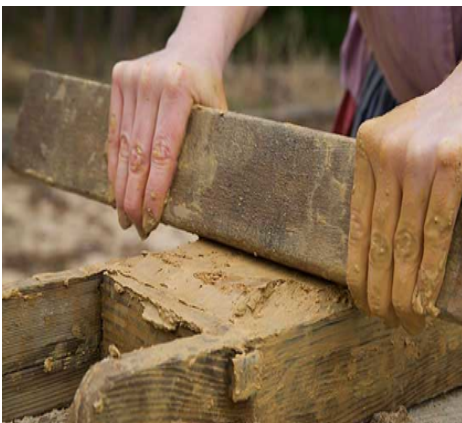
Figure 1. Forming Terra Cotta Unit
(www.history.org/almanack/life/trades/tradebri.cfm)

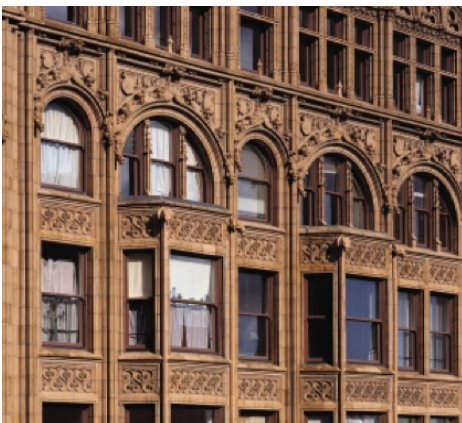
Figure 2. Brown Stone Terra Cotta
(www.traditionalproductgalleries.com)

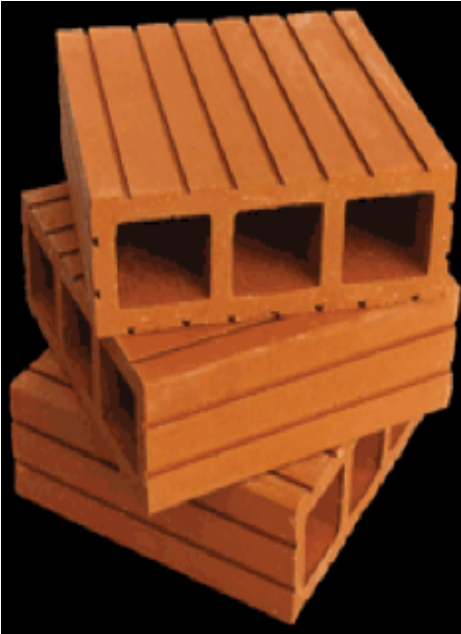
Figure 3. Structural Terra Cotta
(www.sandkuhl.com)

This is also known as fireproof construction terra cotta. It was developed in conjunction with the growth of the High Rise building in America. The lightweight, fireproof, and roughly-finished hollow blocks were ideally suited to span I-beam members in floor, wall and ceiling construction. Structural terra cotta was meant to be covered with a final finished material. Exposed hollow cells were meant to be filled to ensure that water was kept out. Certain varieties are still in production today, but structural terra cotta is no longer a popular building material.

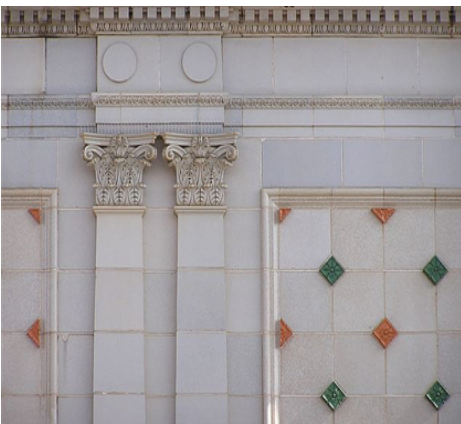
Figure 4. Ceramic Veneer and Glazed Architectural Terra Cotta.
(<http://concretecircles.blogspot.com>)

This is the most complex masonry building material in America. It was developed and refined throughout the first third of the 20th century. The hollow units were hand cast in molds or carved in clay. They were covered in a heavy glaze (often in imitation of stone) and then fired. Glazed architectural terra cotta is also referred to as “architectural ceramics.”

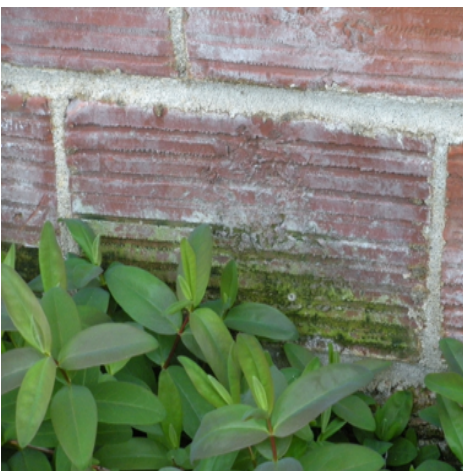
Figure 5. Biological Growth.

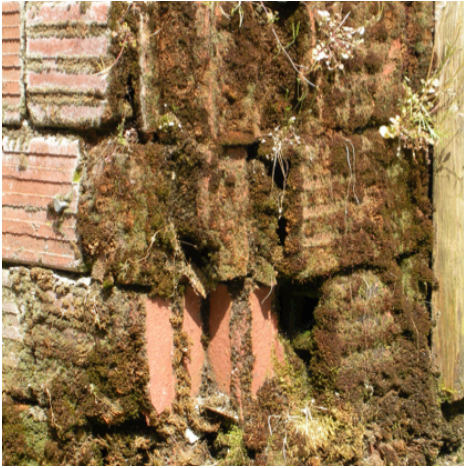
Figure 6. Severe Biological Growth and Deterioration of Terra Cotta.

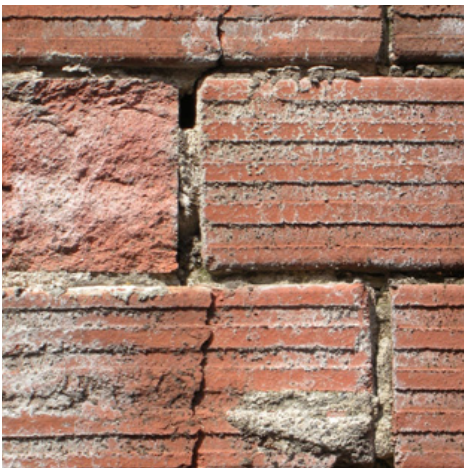
Figure 7. Cracked Terra Cotta.

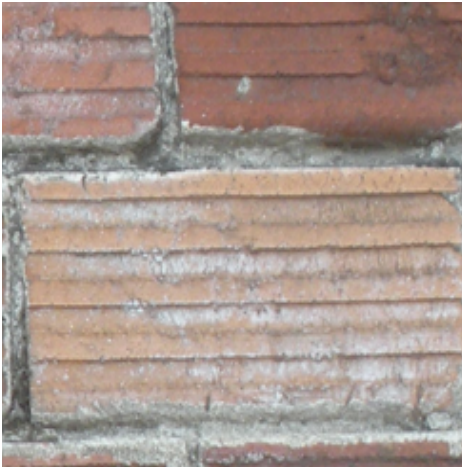
Figure 9. Efflorescence on Terra Cotta

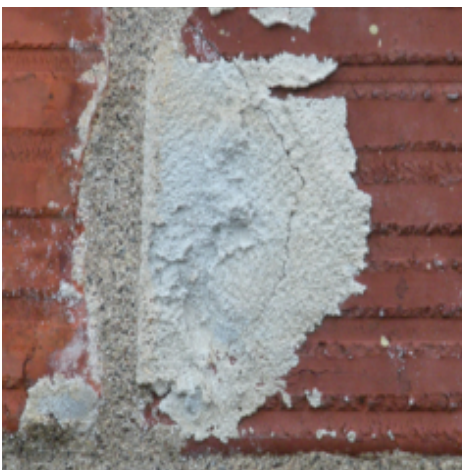
Figure 11. Improper terra cotta repair with incompatible material

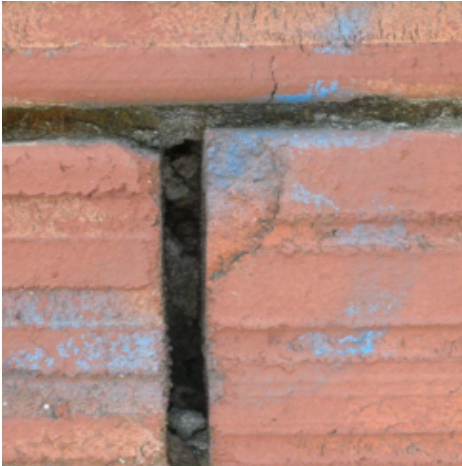
Figure 12. Open Joint with Deteriorated Mortar

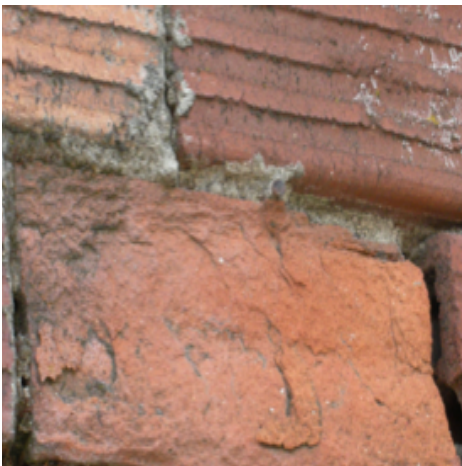
Figure 13. Spalling on Structural Terra Cotta

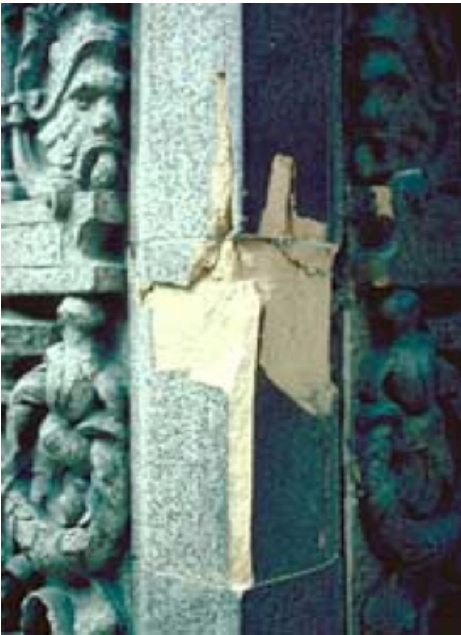
Figure 15. Material Spalling
(Tiller 1979)

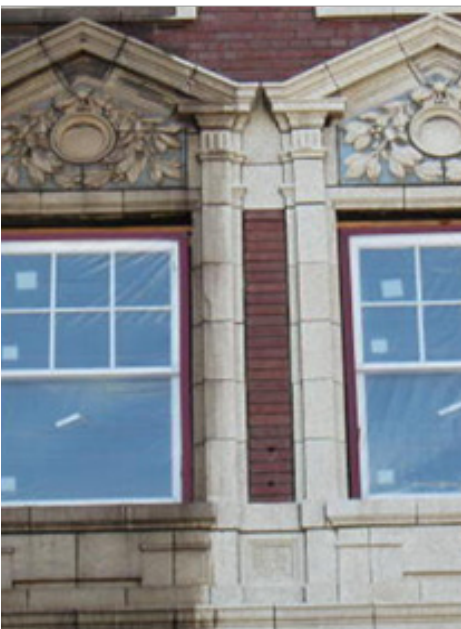
Figure 16. Cleaning Architectural Terra Cotta
(www.preservationarts.net)

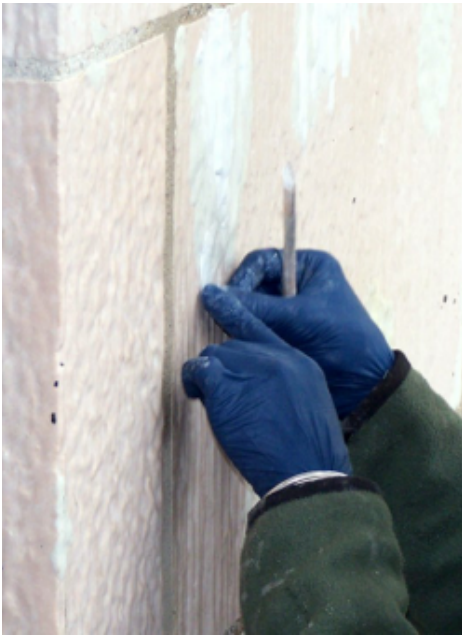
Figure 17. Coating Repair on a Glazed Terra Cotta Unit
(www.preservationarts.net)

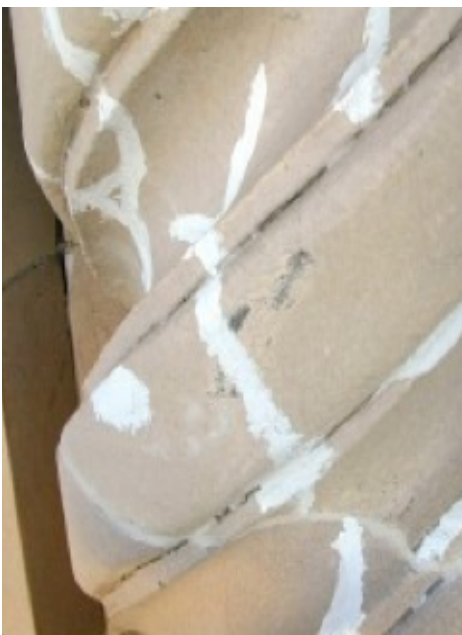
Figure 18. Cracked Terra Cotta Repair
(www.preservationarts.net)

Cracked pieces of terra cotta may be secured with reinforced resin. If the anchors in the terra cotta will not be affected, the cracks can be filled with injected resin that possesses characteristics that are close to the original. If the anchoring system is believed damaged, holes can be drilled into the terra cotta units and anchored into place with metal tubes or bolts grouted in epoxy. This should only be undertaken by a qualified, experienced professional. (M)

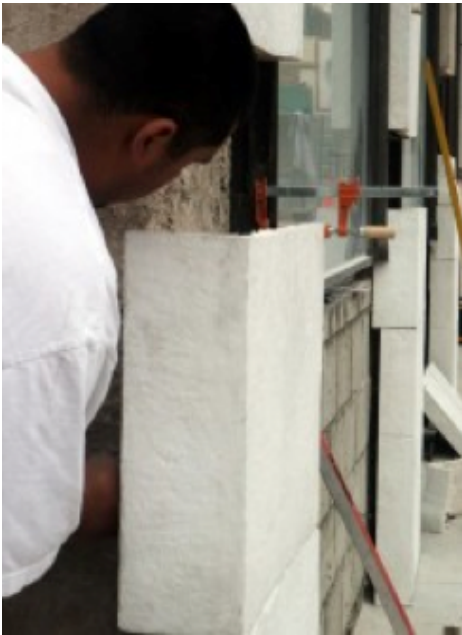
Figure 19. Anchoring of a replacement Terra Cotta Unit
(www.preservationarts.net)

New units must be carefully made to match the original in size and profile, as well as surface color and texture. Other options for replacements can be made with cast stone, glass fiber reinforced cement, and glass fiber reinforced plastic. (M)

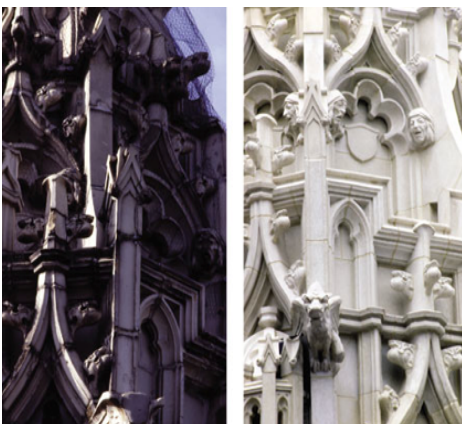
Figure 20. Plastic Repair
(www.preservationarts.net)

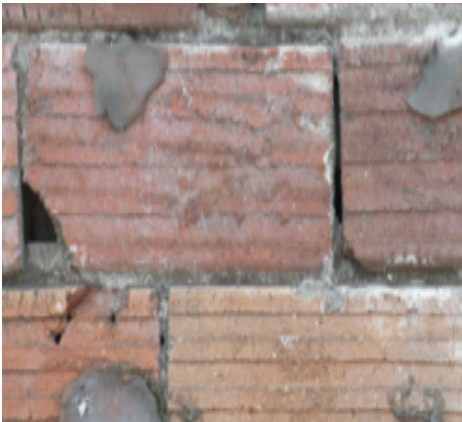
Figure 21. Improper Repair of Structural Terra Cotta

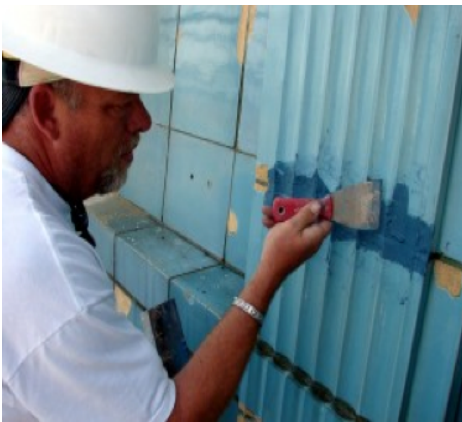
Figure 22. Repointing procedure
(www.preservationarts.net)

Repointing joints should meet three criteria:

- The repointing should reestablish the surface continuity of the wall, leaving no opening through which water can enter.
- The mortar should be softer, and have a lower compressive strength than the terra cotta.
- The mortar should be appropriate in appearance, matching the original in color and texture.

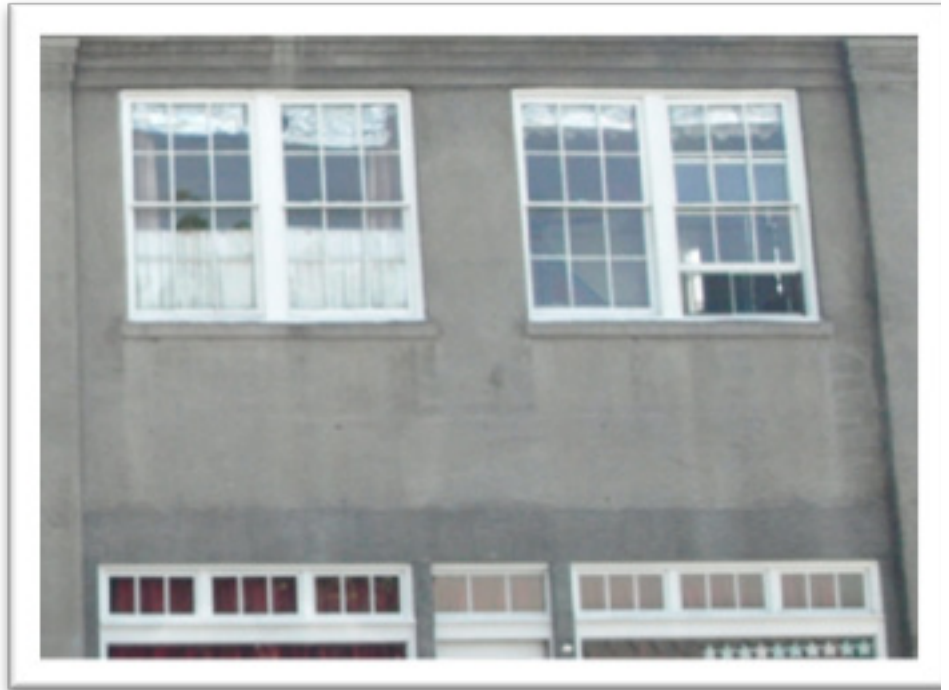
Incompatible color match

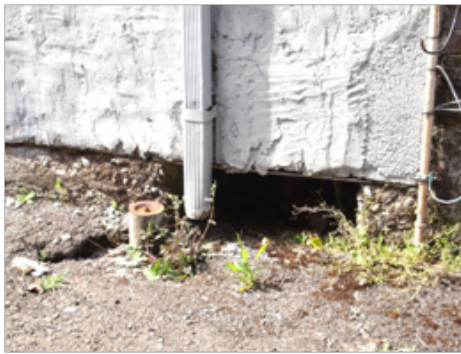
Cracking: Improper Drainage (Weaver 1993, 5)

Cracking: Improper Drainage

Cracks occur in a variety of sizes for a variety of reasons. Cracks that are 2.0 mm or less in size generally have no effect on the structure other than to be unsightly. Sizes between 2.0 and 5.0 mm should be repaired as they will permit water to enter and will, thus, create larger problems. Any crack larger than 5.0 mm is associated with serious structural damage, and requires immediate attention (Weaver, 5).

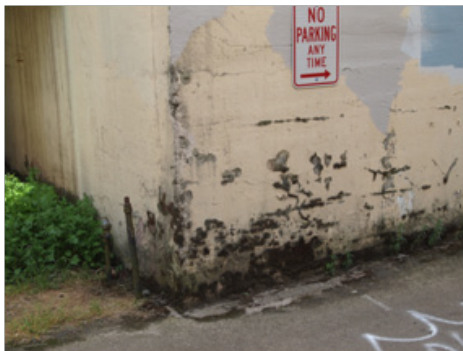
Discoloration/Stains: Improper Drainage

Much of the discoloration that was discovered in Cottage Grove resulted from water staining due to lack of proper drainage. Leaking gutters and pipes, and improper flashing were the most prominent causes of water stains.

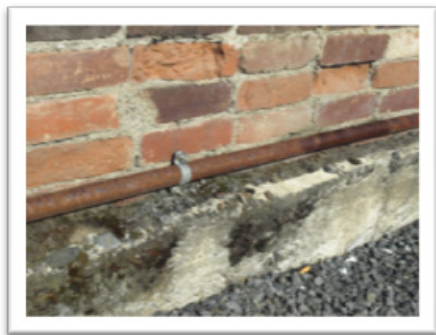
Poor Consolidation: Aggregate Ratios

In several foundations of historic buildings in Cottage Grove, the local aggregate used consisted of large stones and was not properly integrated into the mix. This has resulted in frequent spalling.

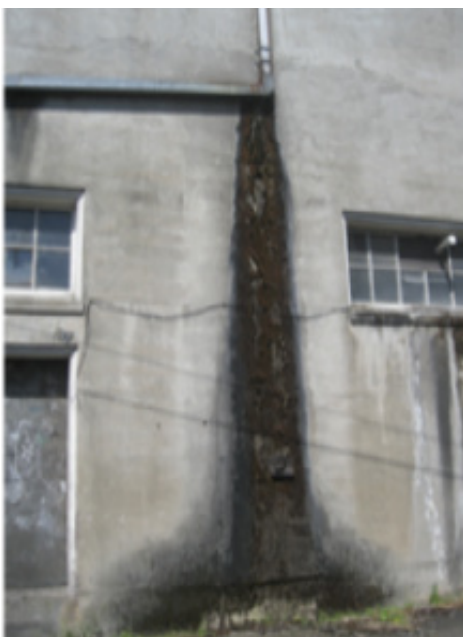
Plant Growth: Improper Drainage with Efflorescence on the right

Inadequate drainage has been caused by lack of proper gutters and pipes at the roof level, and drains at the ground level. Leaking pipes along the walls of buildings and few drains or shallow grading at the building edges are of particular concern. Water retention along the walls and edges of the

concrete buildings has caused frequent biological growth.

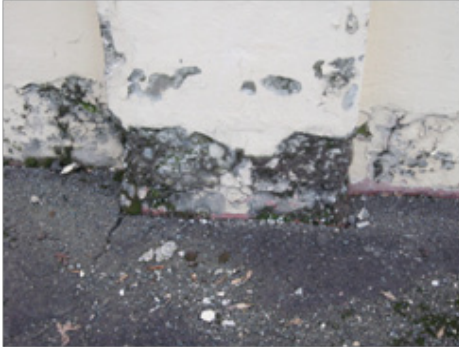
Coving: Repeated water Backsplash with resulting Spalling below

This phenomenon is caused along the foundation of buildings when large amounts of water are present. The water repetitively strikes the same point on the ground and splashes back on the building, creating a horizontal concave recess in the concrete's surface.

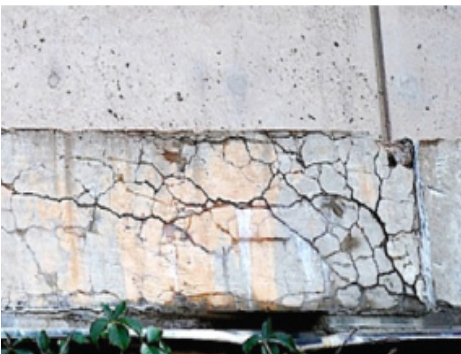
Possible Chemical Reaction Cracking, but laboratory tests are needed for verification

Chemical deterioration is defined by the chemical inaction that allows for the separation of the material components of concrete. Reactions can occur between the aggregates and binder; most common is an alkali-silica reaction (ASR), which creates a gel that expands with contact from water (Winter). Only laboratory testing can confirm if the problem is truly ASR. Additionally, assault from exterior chemicals such as acid rain can damage surface concrete, which leads to water penetration. See also: Chemical Reaction Cracking.

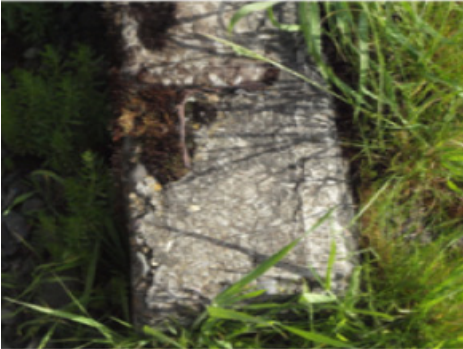
Cracking: Corrosion

If water penetrates far enough into concrete to come in contact with the metal reinforcement, it will cause the metal to rust and expand up to nearly twelve times its original size. The consequential oxidation of the reinforcement metal results in a loss in tensile strength within the concrete structure, and if not resolved, it can lead to structural failure (US Army Corps of Engineers, 25).

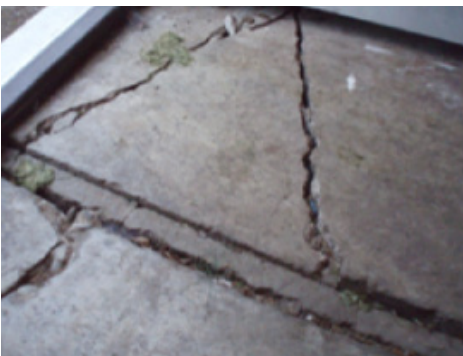
Cracking: Foundation Movement

Due to inadequate bearing area on subgrades or an inadequate placement of expansion joints, material will transfer crack-causing forces to the superstructure (US Army Corps of Engineers, 12).

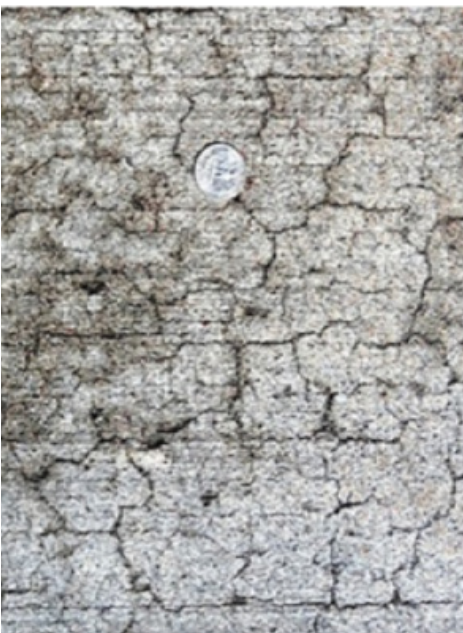
Map Cracking

Map cracking, sometimes known as pattern cracking or crazing, is characterized by fine cracks on the surface of the concrete. Typically, this is

just a cosmetic issue rather than a structural one. Map cracks generally result from a decrease in the volume of the material near the surface or an increase in subsurface material volume. The cracking is usually shallow (less than 1/8-inch deep), but the square area can vary greatly. Map cracking is structurally significant if the pattern follows the pattern of the underlying reinforcing steel or if it demonstrates symptoms of Alkali-Silica Reaction (ASR) (Gromicko and Shepard).

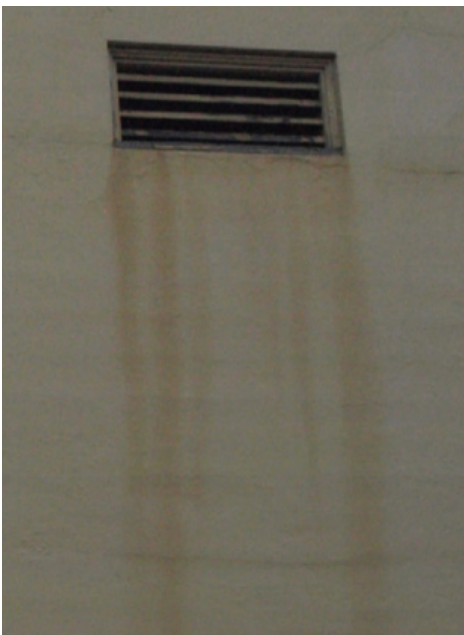
Discoloration from the Oxidation of Metal

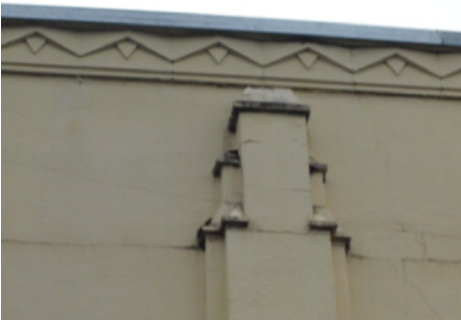
Flow Line

The presence of flow lines is an indicator of a cold joint which occurs when the first layer of concrete has hardened too much before the new layer of concrete is poured (Gromicko and Shepard, Internet). This condition results in a weak bond between the layers and offers an opportunity for water penetration allowing for damage to occur especially with freezing and thawing cycles. Flow lines can also be the result if the concrete was poured into formwork from an excessive height, which allows for material separation. Flow lines are primarily a construction related deficiency (US Army Corps of Engineers, 20).

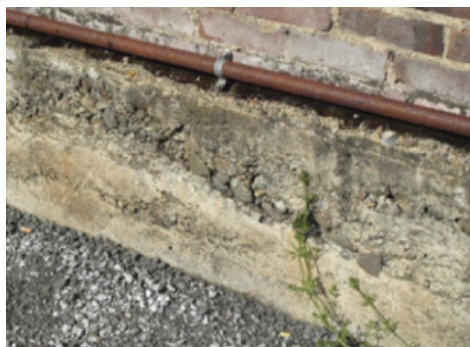
Stratification

The separation of concrete materials into their component parts during the pouring of concrete is referred to as stratification. Early concrete was mixed by hand and were often sourced locally. Naturally, the heavier objects settle near the bottom of the pour, leaving lighter objects near the top.

Stratification is also evident when successive batches differ in appearance. This prevents a homogenous mixture from forming. When poured, the formwork of older concrete was usually not vibrated. Poorly bonded layers or uneven distribution of aggregate and binder within the concrete can alter the structural capacity and performance of the structure (US Army Corps of Engineers, 40).

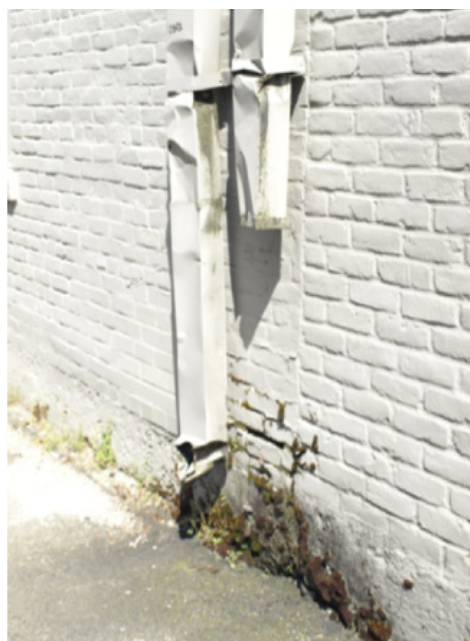
Water Drainage System

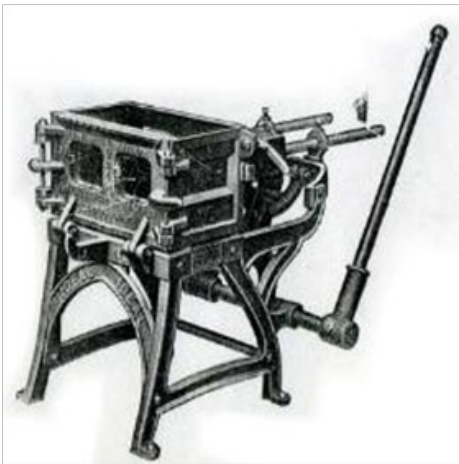
Figure 3: Cast iron block machine (OldHouseWeb)

Thus, it is reasonable to assume he may have purchased a concrete block machine, considering its wide spread availability and popularity at the time. If this is so, Gleason likely also supplied the smaller, rock-faced concrete bricks used on the Colonial Café, a.k.a. Bader Building, now the Grove Tavern and Cafe building, located at 521 Main St. The Colonial Cafe was constructed in 1912, a year after the Cottage Grove Hotel. Rock-faced concrete block, shaped as brick is used on the second story facade, while the primary building is made of brick. This is likely because rock-faced concrete block was fashionable at the time of its construction and was thus intended to be displayed to the public as a symbol of its trendy style. The builder of the Colonial cafe is unknown, however, since it was built only one year after the Cottage Grove Hotel, it was perhaps built by the same contractor, William B. Cooper. If this were known for certain, perhaps it was Cooper who owned a concrete block machine (Simpson 1989, 110-115; Kibbel).

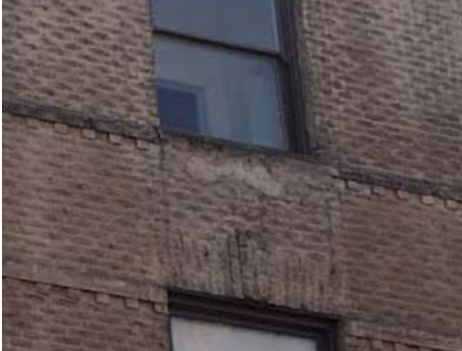
Figure 4: Features the decorative keystones over the windows, and string courses

The unique texture and character of the rock-faced brick on the facades needs to be protected and maintained in order to keep the overall appearance of a two rock-faced buildings in Cottage Grove. There are also character-defining keystones above windows, and decorative string courses and lintels that add detail and depth to the facades. Although these are not rock-faced features they are important masonry elements that need to be protected.

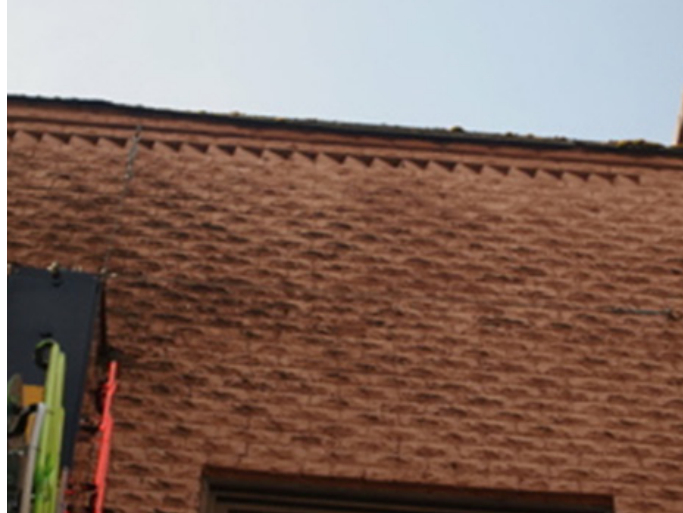
Figure 5: “Mousetoothing” near the top of the façade

The cast brick “mousetoothing” near the roof line is a detail that adds character and definition and should be protected. The simple string course, as well as the dental band dividing the first and second floor, give the front façade dimension and are important masonry features.

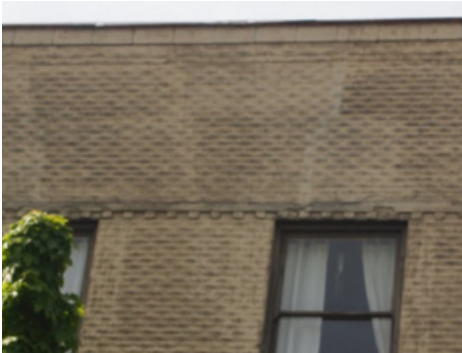
Figure 6: Water Damage

The gutter systems should be replaced with a continuous gutter that has proper flashing and downspouts to direct the water away from the building. The corners have eroded due to water run off, where the gutter ends about a foot before the pavement. Leakage due to cracks in the gutter on the facade has caused efflorescence or water stains. The water has also eroded away many of the lintels and segmental arches above the windows, as well as the string courses which also see a little bit of biological growth. This could be resolved with flashing. The best course of action would be to remove the source of damage, which in this case is water not being directed away from the building.

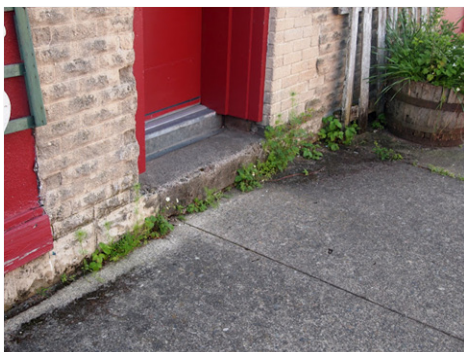
Figure 7: Vegetation

Biological growth is defined as plants or moss growing on the surface near mortar joints or at the foundation of buildings, if water is not running off properly. If the growth is happening at the foundation, the ground around it should be dug up and filled with aggregate, or the sidewalk should be graded so that the water will run down and away from the building. All plants should be removed if they are close to the walls to allow the building to properly breathe and dry after rain.

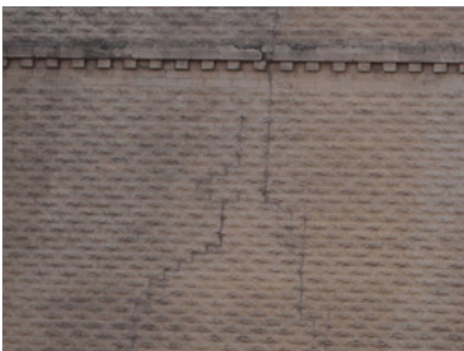
Figure 8: Step Cracking and other vertical cracks indicate horizontal movement

When repairing cracks in masonry buildings, one must always use a mortar weaker than the material to which it adheres. People often mistakenly think that Portland cement, the strongest of all cements, will work wonderfully if used on their buildings for repair. This is a misconception; since all bricks, regular or cement, move with thermal and seismic changes; the mortar must be flexible enough to accommodate those changes. If a building owner or contractor decides to use a material that does not breathe and is inflexible such as Portland cement for mortar repair, the bricks or blocks will not move with the changes and the cracks will eventually become worse. Since bricks and cement absorb moisture, the mortar should as well. When mortar is so dense it will not absorb moisture, the bricks and the cement blocks will be asked to take in more water than their share, and weakening of the material will ensue.

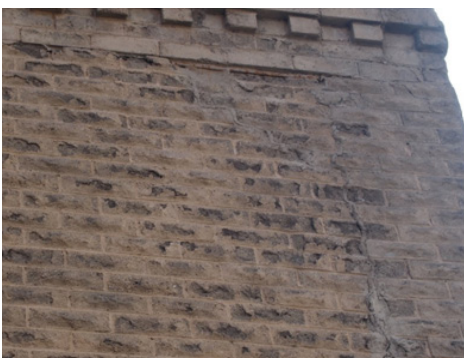
Figure 9: Spalling of rock-faced brick

Spalling is present on many of the bricks and blocks. A few things can cause this. One is the way in which the cement was mixed during the manufacturing of the bricks and blocks. Two, there was not enough curing time. Cast blocks should be cured for approximately two weeks after formation. Spalling comes in the form of popping and surface shearing of bricks and blocks. Many of the cast bricks in Cottage Grove are experiencing spalling, and this can be repaired a few different ways. The first way would be to determine if the bricks are cast on all four sides, as in the back of the brick that is not showing has the same rock face pattern. A mason would remove the damaged brick, turn it around, and replace it. Unfortunately and in most cases, the rock face brick molds were three-sided leaving the bricks or blocks with a blank surface at the back, meaning it can not be turned around. In the case of three sided bricks, a qualified mason could per-

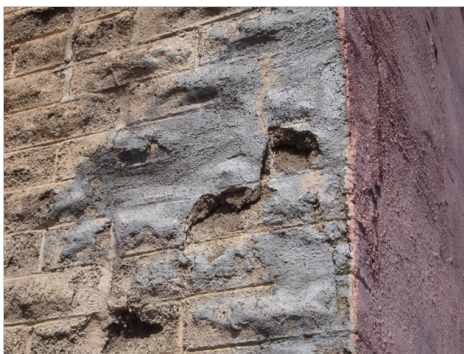
Figure 10: Inappropriate brick repair

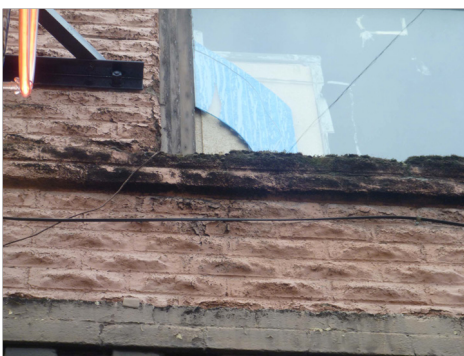
Figure 11: Biological growth can be seen on a large percentage of the front façade. A majority is underneath the windows indicating possible water drainage problems from the windowsills

Water damage can be avoided by making sure drainage at the windowsills and gutter are sufficiently moving water away from the building. In Cottage Grove, there are gutters that do not go all the way to the pavement, causing water to drain directly on to the corner of buildings. Or, gutters on the top of a building lead water right on to the front elevation and not away from the building. It would be advisable to add on to these gutters so they sufficiently drain the water.

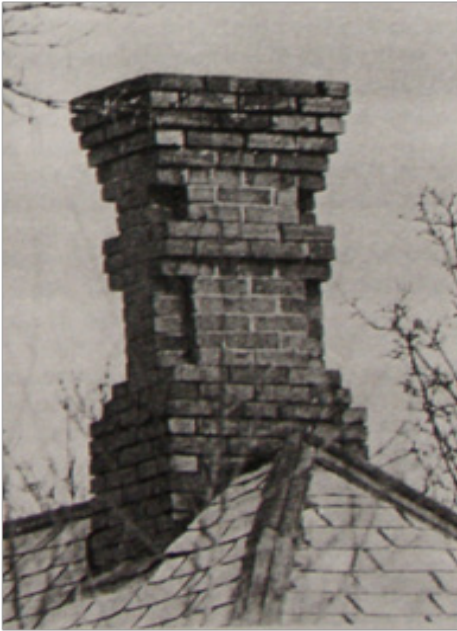
Fig. 3 Chimney by Wallace, Cottage Grove, 1890
(Dole 1983, 21)

Wallace specialized in handsome chimneys, cutting the bricks to unusual shapes such as diamonds and hearts.

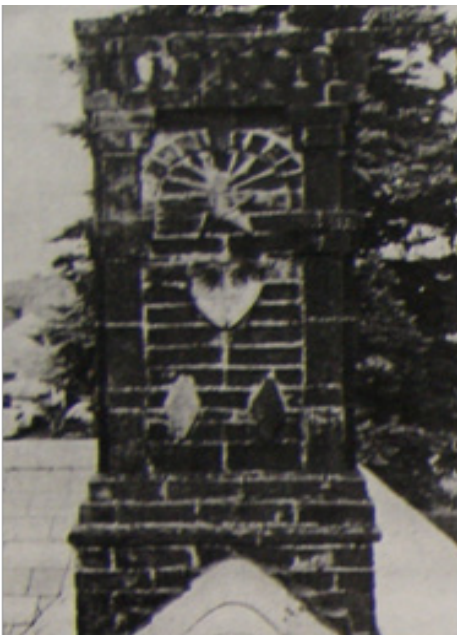
Fig. 4 Chimney by Wallace, Springfield, 1873.
(Dole 1983, 20)

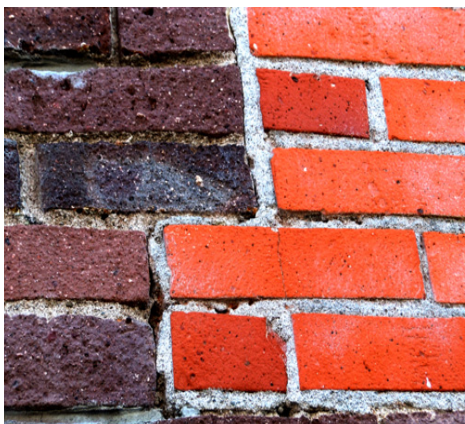
Fig. 9 Improper brick and mortar repair

Figure 9 demonstrates an historic brick wall (left), which was repaired incorrectly (right). The historic bond was not continued and while the brick size is relatively similar, color matching has been completely overlooked. The historic mortar has not been replicated. The repair mortar is clearly Portland cement, based on its gray color and lack of white dust when rubbed. The color of the repair mortar does not match the historic mortar, but the biggest problem here is the incorrect use of impervious Portland cement.

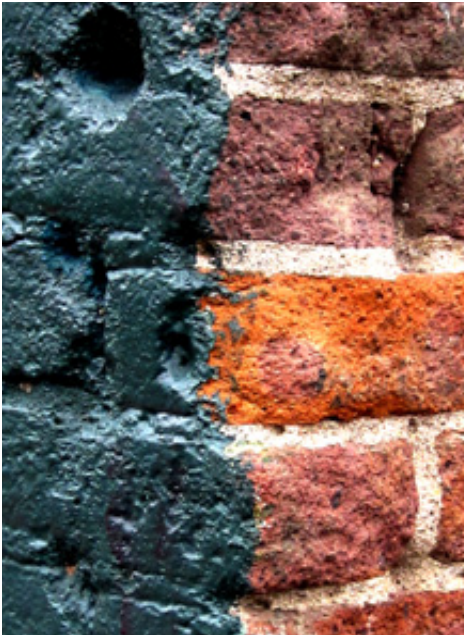
Fig. 10 Historic masonry that has been continually painted and maintained

bricks, making paint's removal a risky venture as doing so can harm the brick's patina and structure, permitting greater erosion. Applying modern paint to an unpainted building may seal the building, trapping water and creating moisture problems both on the interior and exterior of the building. Figures 10 and 11 are examples of historic masonry that was either originally painted or has been painted for an extended amount of time. In these cases, it is crucial to keep the masonry painted as trying to remove it could damage the brick.
