Masonry Conservation Handbook

Cottage Grove, Oregon

University of Oregon
Architecture and Allied Arts
Historic Preservation Program

Authors:
Graduate & Undergraduate students
AAAP 4/510: Building Pathology - Masonry

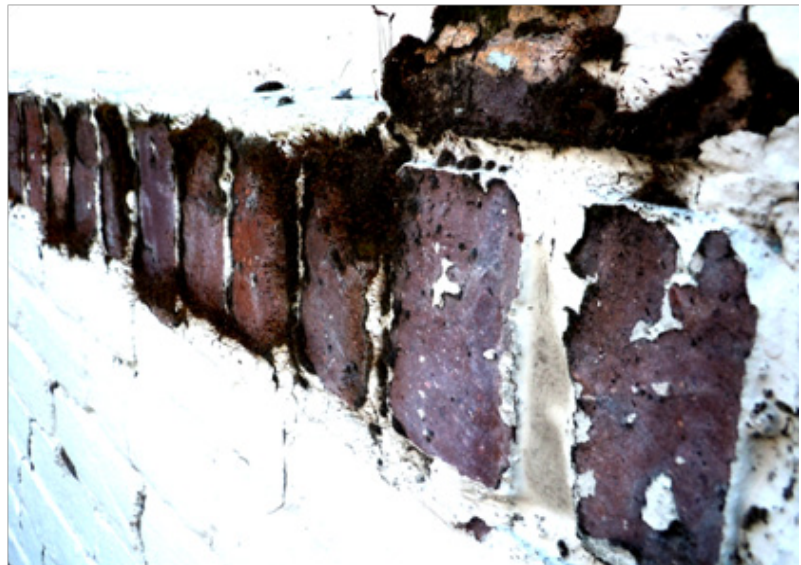
Fig. 11 Historic masonry painted with modern latex paint that will not stick due to water problems

bricks, making paint's removal a risky venture as doing so can harm the brick's patina and structure, permitting greater erosion. Applying modern paint to an unpainted building may seal the building, trapping water and creating moisture problems both on the interior and exterior of the building. Figures 10 and 11 are examples of historic masonry that was either originally painted or has been painted for an extended amount of time. In these cases, it is crucial to keep the masonry painted as trying to remove it could damage the brick.

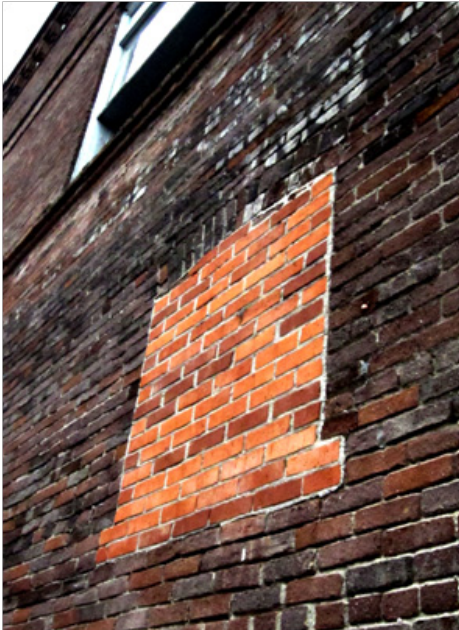
Fig. 12 Improper historic window infill

to match the historic material and mortar type. In addition, it is important to retain the historic window material and pane pattern. If windows need to be replaced, match the new window as closely as possible to the historic window to maintain the integrity of the opening. Figure 12 is an example of an improper infill.

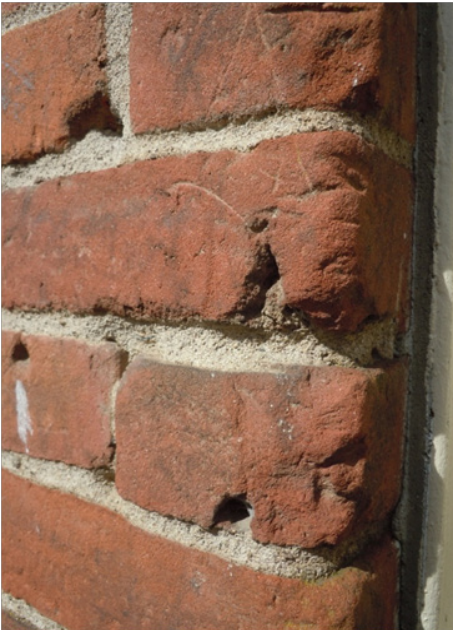
Fig. 16 Hand molded bricks

Figure 16 depicts handmade bricks from Cottage Grove and shows how the softer, handmade bricks can be more susceptible to damage. This does not mean that these bricks are unusable, or should be replaced if in good condition. These bricks just need to be treated with very mild cleaning methods, and if historically painted, these bricks need to continue to be painted today.

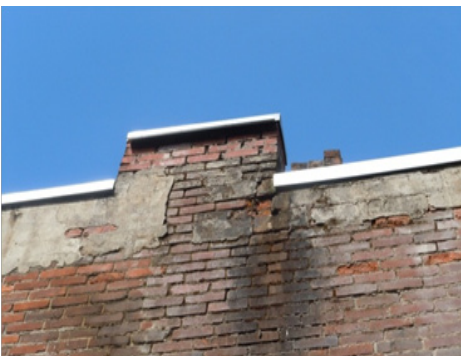
Fig. 18 Wall with flashing. Water being diverted away from parapet after years of damage from water infiltration.

Many historic buildings were not designed to have flashing at the parapet of the roof, and have since been retrofitted to protect from water infiltration. Adding flashing to an historic building that is already having issues, as was done in Figure 18, will aid in controlling water issues, but the brick may still need to be repaired. Flashing is a very good first step if repair cannot occur right away. Flashing will not fix every problem, but should be part of an integrated approach.

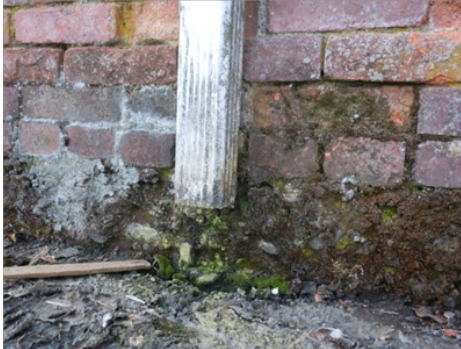
Fig. 19 Water is not being diverted away from the foundation of this building, causing rising damp

In Figure 19, water is being taken from the roof via a downspout, but is then splashing back on the foundation of the building and causing issues of rising damp (water being wicked up a masonry wall, that is not allowed adequate time to dry on a regular basis).

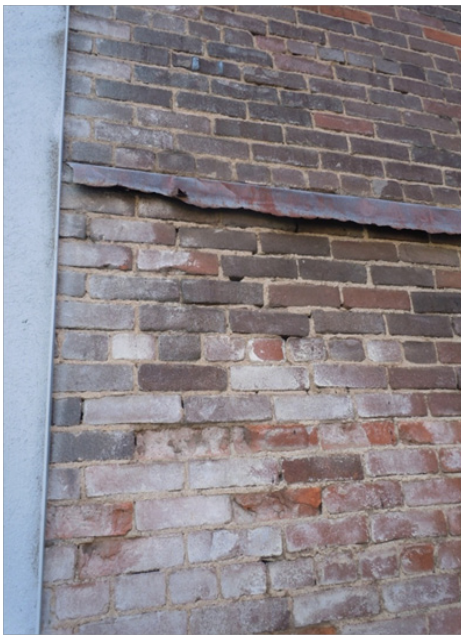
Fig. 20 Corroded metal imbedded in brick masonry

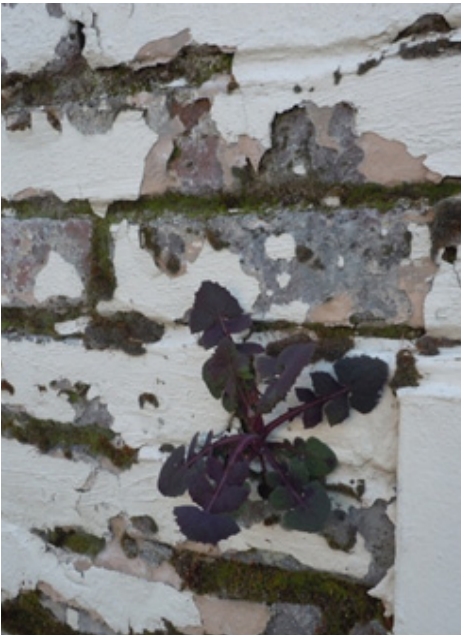
Fig. 21 Chipped paint is allowing water to enter into the joints of this brick wall

If the wall has been covered with modern paint and chips begin to occur on the wall, water can get trapped behind the paint and cause layers of the brick to spall or delaminate. Figure 21 is an example of this. Walls that were originally painted need to remain as such, because removing the paint may cause the fired glaze on the surface of the brick face to be taken off as well, leaving the entire brick susceptible to water infiltration. Also, biological growth keeps moisture on the building and does not allow it to fully dry out, which can equally create problems.

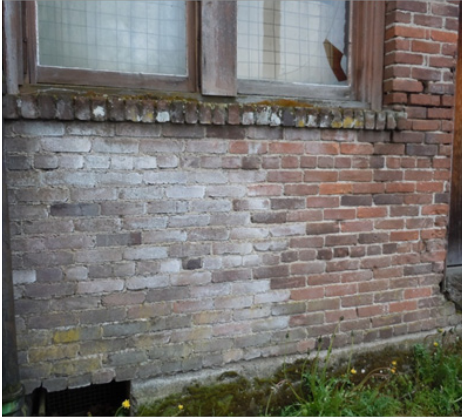
Fig. 22 Efflorescence on the surface of a brick wall

Figure 22 shows a defined area of efflorescence staining on a brick building. This staining appears to have occurred for two reasons. First, there is not adequate flashing on the window sill, which is permitting water to enter into the mortar joints of the sill and allowing it to travel into and down the masonry wall. If the salts staining the surface have imbedded into the brick face, they will eventually cause the brick to delaminate, chip, and spall.

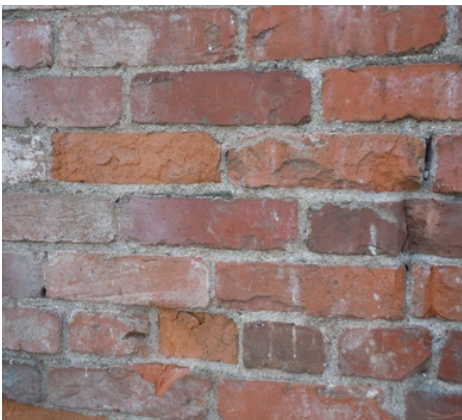
Fig. 23 Spalling and loss of mortar due to efflorescence

Figure 23 is an example of the deteriorating effects of efflorescence. The expansive pressure of the dissolved salts has caused the bricks to delaminate and spall. Layers and chunks of brick, along with mortar, have cracked and fallen off of the building, leaving the softer interior portion of the brick open and vulnerable to water infiltration and expansion.

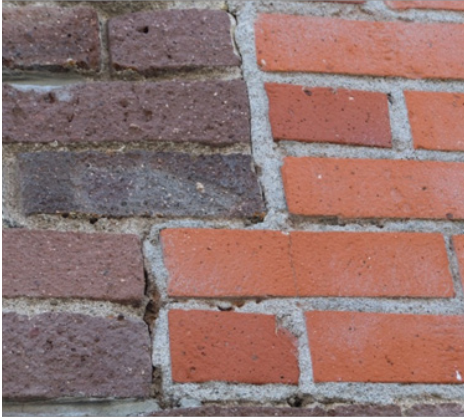
Fig. 24 Incompatible brick infill

In Figures 24 and 25, the incompatible infill composed of modern bricks and Portland cement mortar is putting pressure on the surrounding wall. This has caused the wall to bow and the mortar to crack. Proper restoration in these examples would have been a compatible infill consisting of bricks with a similar hardness and mortar of a similar lime and sand content as was used in the original wall.

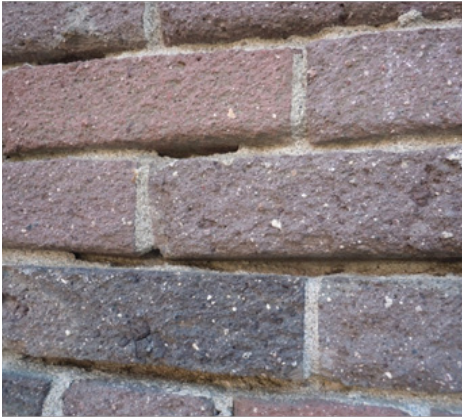
Fig. 26 Effects of abrasive cleaning on brick and mortar

Figure 26 shows the effects abrasive cleaning can have on a masonry building. The glazed surface of the brick has been removed, leaving grooves, gaps, and holes in the brick and exposing it to moisture. In addition, the mortar has been severely eroded, adding to the potential deterioration. Repointing is necessary to restore the wall to its original state as well as protect the wall from further damage. Any heavily deteriorated bricks may be able to be turned around and the inside face used for the exterior. If this is not an option, some bricks may need to be replaced if they are beyond small patching and repair.

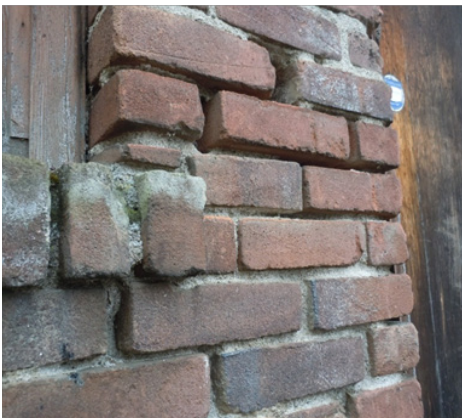
Fig. 27 Left untreated, the mortar gaps in this picture eventually cause structural damage to the building

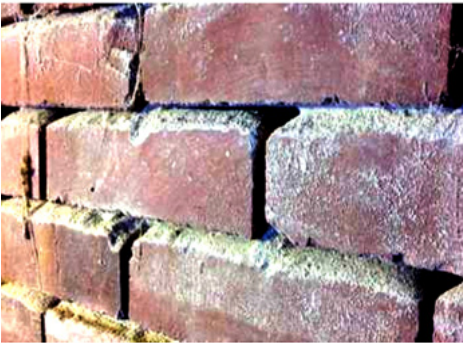
Fig. 28 Viable historic brick that needs repointing
(www.indestructables.com)

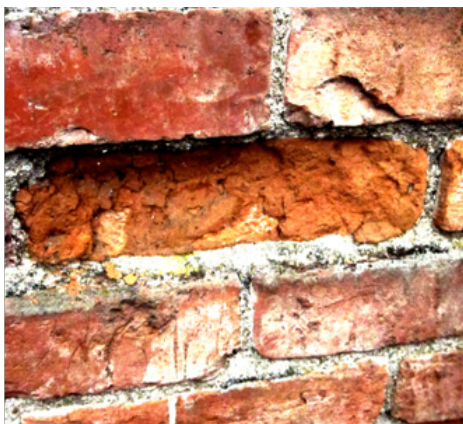
Fig. 29 Deteriorated historic brick unable to be reversed

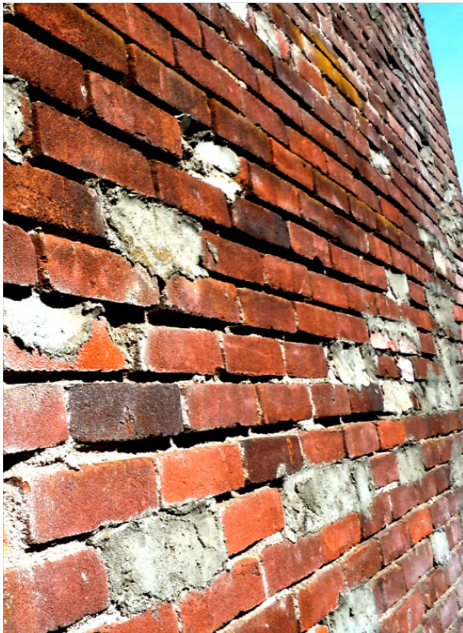
Fig. 30 Improperly replaced brick affects both the structural integrity and aesthetic qualities of an historic building

If brick reversal is not a possibility, brick replacement is the best solution. It is inappropriate and problematic both structurally and aesthetically to replace a brick with a large patch of Portland cement or similar material as illustrated in Figure 30. Historic bricks should be replaced either with reclaimed historic bricks or with new bricks. Whether replacing with reclaimed or new brick, it is necessary to match the material characteristics such as color, size, texture, hardness and porosity in order to preserve the visual character and structural integrity of the building. If a deteriorated area is highly visible and matching brick cannot be found, brick from an inconspicuous area on the structure could be removed and used. The less visible area can then be repaired with as close a match as possible.

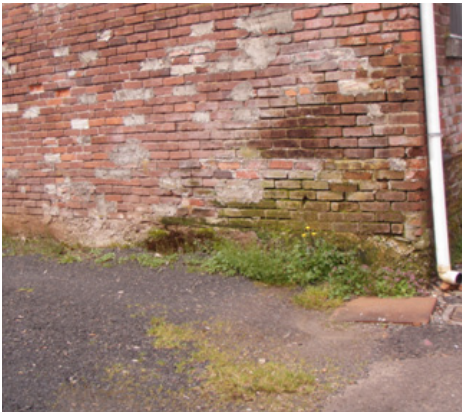
Fig. 31 Biological Growth

Growth on the masonry surface or within masonry joints of biological origin. This includes, but is not limited to algae, moss, small plants and grasses, lichen (a dark colored fungus), ivy, fungi, mold, and other bacteria. These can trap moisture in the wall and cause deterioration of mortar.

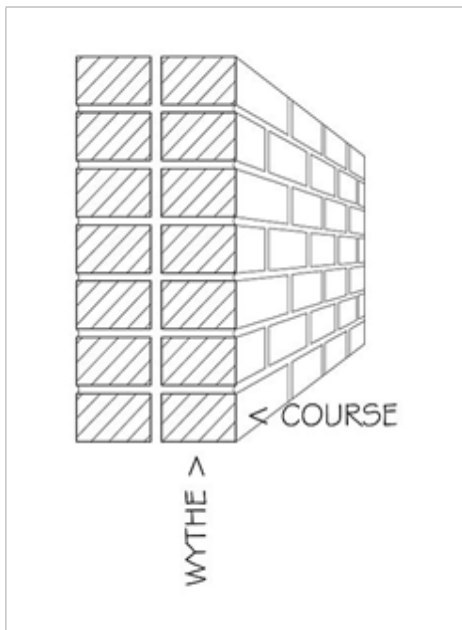
Fig. 32 Brick Course and Wythe
(<http://en.wikipedia.org/wiki/Wythe>)

The course is a row of bricks and the wythe is the term used for the width of one brick. The example in Figure 32 is two-wythes thick and is laid in a running bond course.
